Access Compliance Report

Public Rights-of-Way

| Intersection ID: 11457 | Main Street: TRYON-CHURCH_CONNECTOR_ST | Cross Street: N_CHURCH_ST | Location: E |
| ADA ID: B3DA1F7FA0FC | Curb Cut Type: MedianRefuge2 | Initial Pass/Fail: Fail | Overall Compliance: No |

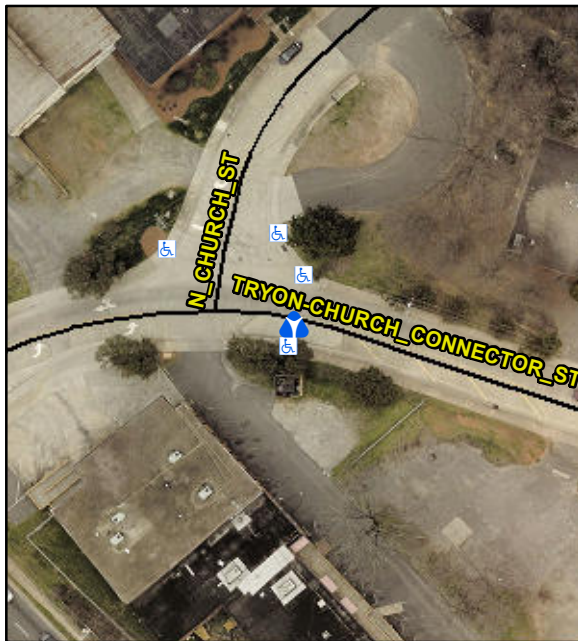
| Codes/Mitigation Info/Possible Solution | | | Severity Score: 25 |

| Compliance | Description | Data | Compliance | Description | Data |
|---|---|---|---|---|---|
| No | Refuge 1 Slope (%) | 6.3 | N/A | Gutter 1 Slope (%) | N/A |
| No | Refuge 2 Slope (%) | 7.2 | N/A | Gutter 2 Slope (%) | N/A |

Remove & Replace Entire Refuge.

Total Cost: \$ 3000.00
