# Access Compliance Report

## Public Rights-of-Way

### (Island Curb Cuts)

Intersection ID: 15477	Main Street: W_TYVOLA_RD	Cross Street: CASCADE_POINTE_BV	Location: S
ADA ID: B49256657227	Curb Cut Type: IslandRefuge3	Initial Pass/Fail: Fail	Overall Compliance: No
Codes/Mitigation Info/Possible Solution		Field Measurements/Component Compliance

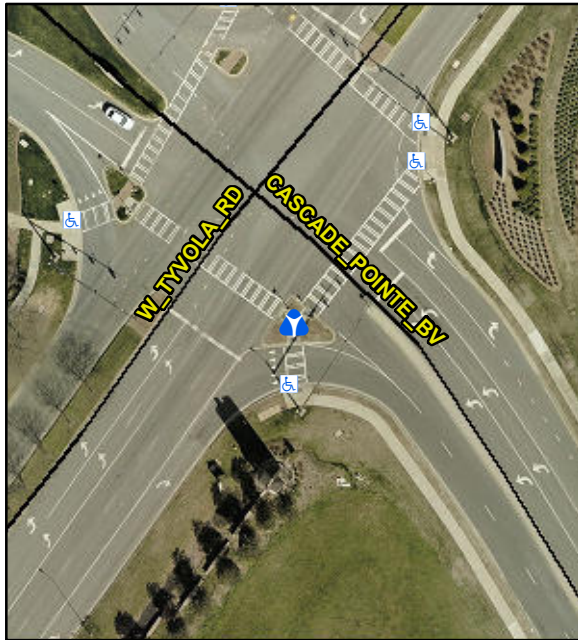
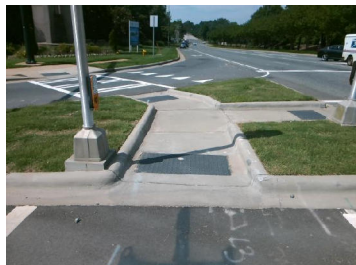
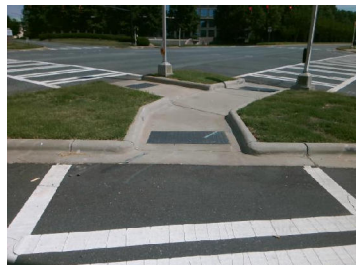
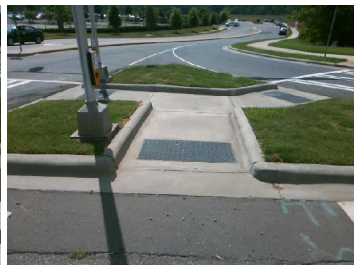
Compliance	Description	Data	Compliance	Description	Data
Yes	Refuge 1 Length (In)	110.0	N/A	Gutter 1 Ponding?	N/A
No	Refuge 1 Width (In)	56.0	N/A	Gutter 1 Lip Ht (In)	N/A
Yes	Refuge 1 Slope (%)	0.4	N/A	Gutter 1 Slope (%)	N/A
Yes	Refuge 1 X Slope (%)	3.8	N/A	Gutter 1 X Slope (%)	N/A
N/A	Painted X Walk1?	Yes	N/A	DWS 1 Provided?	N/A
N/A	X Walk 1 Direction	To NE	N/A	DWS 1 Contrast?	N/A
N/A	X Walk 1 Width (In)	117.0	N/A	DWS 1 Length (In)	N/A
N/A	Road 1 Slope (%)	6.3	N/A	DWS 1 Full Width?	N/A
N/A	Road 1 X Slope (%)	2.1	N/A	DWS 1 Offset (In)	N/A
Yes	Refuge 2 Length (In)	118.0	N/A	Gutter 2 Ponding?	N/A
No	Refuge 2 Width (In)	59.0	N/A	Gutter 2 Lip Ht (In)	N/A
No	Refuge 2 Slope (%)	6.8	N/A	Gutter 2 Slope (%)	N/A
Yes	Refuge 2 X Slope (%)	2.4	N/A	Gutter 2 X Slope (%)	N/A
N/A	Painted X Walk2?	Yes	N/A	DWS 2 Provided?	N/A
N/A	X Walk 2 Direction	To S	N/A	DWS 2 Contrast?	N/A
N/A	X Walk 2 Width (In)	108.0	N/A	DWS 2 Length (In)	N/A

N/A	Road 2 Slope (%)	3.1	N/A	DWS 2 Full Width?	N/A
N/A	Road 2 X Slope (%)	4.1	N/A	DWS 2 Offset (In)	N/A
Yes	Refuge 3 Length (in)	90.0	N/A	Gutter 3 Ponding?	N/A
No	Refuge 3 Width (in)	58.0	N/A	Gutter 3 Lip Ht (in)	N/A
Yes	Refuge 3 Slope (%)	3.6	N/A	Gutter 3 Slope (%)	N/A
Yes	Refuge 3 XSlope (%)	3.8	N/A	Gutter 3 XSlope (%)	N/A
N/A	Painted X Walk3?	Yes	N/A	DWS 3 Provided?	N/A
N/A	X Walk 3 Direction	To NW	N/A	DWS 3 Contrast?	N/A
N/A	X Walk 3 Width (in)	113.0	N/A	DWS 3 Length (in)	N/A
N/A	Road 3 Slope (%)	2.9	N/A	DWS 3 Full Width?	N/A
N/A	Road 3 XSlope (%)	3.2	N/A	DWS 3 Offset (in)	N/A
Yes	Any Obstructions?	N/A	N/A	Storm Grate/Utility Hazard?	N/A
N/A	Obstruction Type		N/A	Storm Grate/Utility Type	
		N/A			N/A
N/A	Surface Condition	Good

**Remove & Replace Entire Refuge.**

**\$ 3000.00**
