Access Compliance Report

Public Rights-of-Way

(Island Curb Cuts)

| Intersection ID: 50762 | Main Street: SCOTT_CREEK_DR | Cross Street: BACK_CREEK_CHURCH_RD | Location: E |

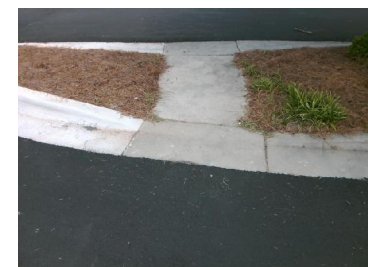
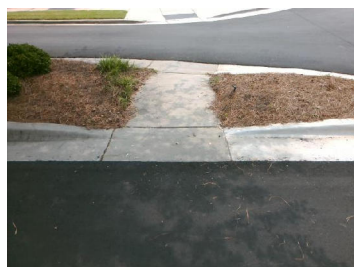
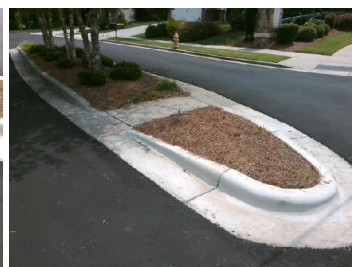
| ADA ID: B6490744228D | Curb Cut Type: MedianRefuge2 | Initial Pass/Fail: Fail | Overall Compliance: No |

| Compliance | Description | Data | Compliance | Description | Data |
|---|---|---|---|---|---|
| No | Refuge 1 Width (In) | 47.5 | No | Gutter 1 Lip Ht (In) | 0.75 |
| No | Refuge 2 Width (In) | 47.5 | No | Gutter 2 Lip Ht (In) | 0.75 |

Remove & Replace Entire Refuge.
Remove & Replace Gutter.
