# Access Compliance Report

## Public Rights-of-Way

### (Island Curb Cuts)

Intersection ID: 10025682	Main Street: EAST_BV	Cross Street: N/A	Location: N
ADA ID: B6A9C05870B7	Curb Cut Type: MedianRefuge2	Initial Pass/Fail: Fail	Overall Compliance: No
Severity Score: 12.5			
Codes/Mitigation Info/Possible Solution		Field Measurements/Component Compliance

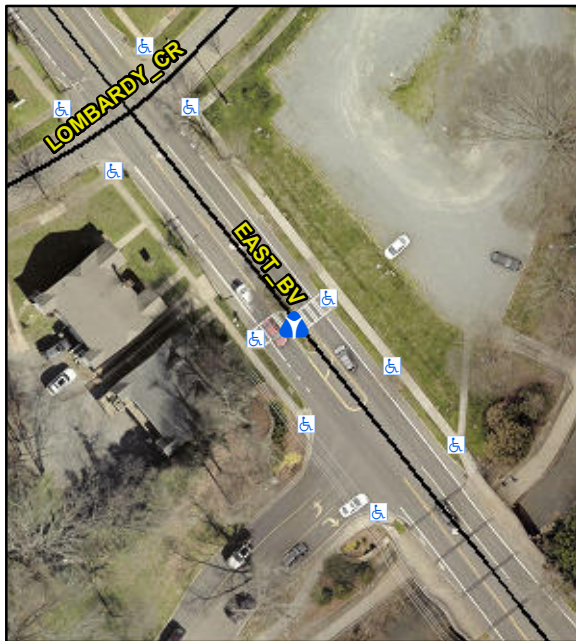
Compliance	Description	Data	Compliance	Description	Data
Yes	Refuge 1 Length (In)	44.25	N/A	Gutter 1 Ponding?	N/A
Yes	Refuge 1 Width (In)	124.0	N/A	Gutter 1 Lip Ht (In)	N/A
No	Refuge 1 Slope (%)	5.2	N/A	Gutter 1 Slope (%)	N/A
Yes	Refuge 1 X Slope (%)	0.8	N/A	Gutter 1 X Slope (%)	N/A
N/A	Painted X Walk1?	Yes	N/A	DWS 1 Provided?	N/A
N/A	X Walk 1 Direction	To SW	N/A	DWS 1 Contrast?	N/A
N/A	X Walk 1 Width (In)	110.0	N/A	DWS 1 Length (In)	N/A
N/A	Road 1 Slope (%)	1.1	N/A	DWS 1 Full Width?	N/A
N/A	Road 1 X Slope (%)	2.4	N/A	DWS 1 Offset (In)	N/A
Yes	Refuge 2 Length (In)	44.25	N/A	Gutter 2 Ponding?	N/A
Yes	Refuge 2 Width (In)	124.0	N/A	Gutter 2 Lip Ht (In)	N/A
No	Refuge 2 Slope (%)	6.1	N/A	Gutter 2 Slope (%)	N/A
Yes	Refuge 2 X Slope (%)	0.4	N/A	Gutter 2 X Slope (%)	N/A
N/A	Painted X Walk2?	Yes	N/A	DWS 2 Provided?	N/A
N/A	X Walk 2 Direction	To NE	N/A	DWS 2 Contrast?	N/A
N/A	X Walk 2 Width (In)	112.0	N/A	DWS 2 Length (In)	N/A

N/A	Road 2 Slope (%)	0.6	N/A	DWS 2 Full Width?	N/A
N/A	Road 2 X Slope (%)	1.2	N/A	DWS 2 Offset (In)	N/A
N/A	Refuge 3 Length (in)	N/A	N/A	Gutter 3 Ponding?	N/A
N/A	Refuge 3 Width (in)	N/A	N/A	Gutter 3 Lip Ht (in)	N/A
N/A	Refuge 3 Slope (%)	N/A	N/A	Gutter 3 Slope (%)	N/A
N/A	Refuge 3 XSlope (%)	N/A	N/A	Gutter 3 XSlope (%)	N/A
N/A	Painted X Walk3?	N/A	N/A	DWS 3 Provided?	N/A
N/A	X Walk 3 Direction	N/A	N/A	DWS 3 Contrast?	N/A
N/A	X Walk 3 Width (in)	N/A	N/A	DWS 3 Length (in)	N/A
N/A	Road 3 Slope (%)	N/A	N/A	DWS 3 Full Width?	N/A
N/A	Road 3 XSlope (%)	N/A	N/A	DWS 3 Offset (in)	N/A
Yes	Any Obstructions?	N/A	N/A	Storm Grate/Utility Hazard?	N/A
N/A	Obstruction Type		N/A	Storm Grate/Utility Type	
			N/A		N/A
N/A	Surface Condition	Good

**Remove & Replace Entire Refuge.**

Total Cost: \$ 3000.00
