Access Compliance Report

Public Rights-of-Way

(Island Curb Cuts)

Intersection ID: 9661	Main Street: CAMROSE_DR	Cross Street: THE_PLAZA	Location:	W
ADA ID: B703308B948C	Curb Cut Type: MedianRefuge2	Initial Pass/Fail: Pass	Overall Compliance: No	Severity Score: 10
Codes/Mitigation Info/Possible Solution		Field Measurements/Component Compliance

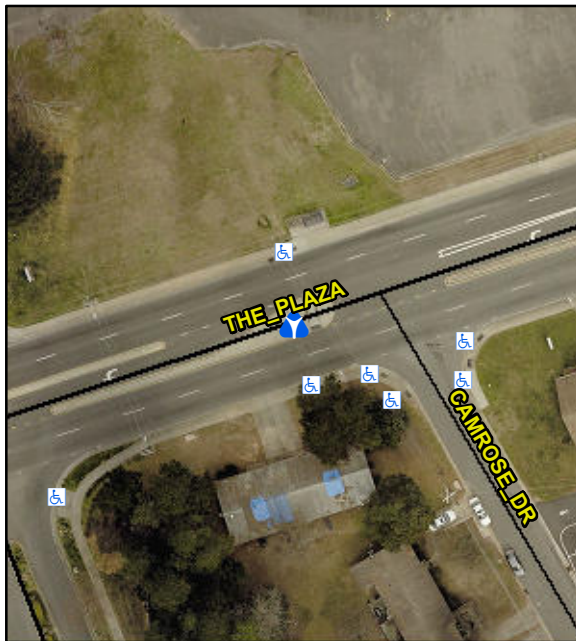
Compliance	Description	Data	Compliance	Description	Data
Yes	Refuge 1 Length (In)	105.25	Yes	Gutter 1 Ponding?	No
Yes	Refuge 1 Width (In)	74.0	Yes	Gutter 1 Lip Ht (In)	0.0
Yes	Refuge 1 Slope (%)	0.7	Yes	Gutter 1 Slope (%)	1.2
Yes	Refuge 1 X Slope (%)	1.9	Yes	Gutter 1 X Slope (%)	0.9
N/A	Painted X Walk1?	No	Yes	DWS 1 Provided?	Yes
N/A	X Walk 1 Direction	To S	Yes	DWS 1 Contrast?	Yes
N/A	X Walk 1 Width (In)	N/A	Yes	DWS 1 Length (In)	24.0
N/A	Road 1 Slope (%)	1.2	Yes	DWS 1 Full Width?	Yes
N/A	Road 1 X Slope (%)	2.0	No	DWS 1 Offset (In)	4.0
Yes	Refuge 2 Length (In)	105.25	Yes	Gutter 2 Ponding?	No
Yes	Refuge 2 Width (In)	74.0	Yes	Gutter 2 Lip Ht (In)	0.0
Yes	Refuge 2 Slope (%)	1.5	No	Gutter 2 Slope (%)	5.2
Yes	Refuge 2 X Slope (%)	0.6	Yes	Gutter 2 X Slope (%)	1.9
N/A	Painted X Walk2?	No	Yes	DWS 2 Provided?	Yes
N/A	X Walk 2 Direction	To N	Yes	DWS 2 Contrast?	Yes
N/A	X Walk 2 Width (In)	N/A	Yes	DWS 2 Length (In)	24.0

N/A	Road 2 Slope (%)	1.3	Yes	DWS 2 Full Width?	Yes
N/A	Road 2 X Slope (%)	1.5	No	DWS 2 Offset (In)	7.0
N/A	Refuge 3 Length (in)	N/A	N/A	Gutter 3 Ponding?	N/A
N/A	Refuge 3 Width (in)	N/A	N/A	Gutter 3 Lip Ht (in)	N/A
N/A	Refuge 3 Slope (%)	N/A	N/A	Gutter 3 Slope (%)	N/A
N/A	Refuge 3 XSlope (%)	N/A	N/A	Gutter 3 XSlope (%)	N/A
N/A	Painted X Walk3?	N/A	N/A	DWS 3 Provided?	N/A
N/A	X Walk 3 Direction	N/A	N/A	DWS 3 Contrast?	N/A
N/A	X Walk 3 Width (in)	N/A	N/A	DWS 3 Length (in)	N/A
N/A	Road 3 Slope (%)	N/A	N/A	DWS 3 Full Width?	N/A
N/A	Road 3 XSlope (%)	N/A	N/A	DWS 3 Offset (in)	N/A
Yes	Any Obstructions?	No	N/A	Storm Grate/Utility Hazard?	No
N/A	Obstruction Type		N/A	Storm Grate/Utility Type	
		N/A			N/A
N/A	Surface Condition	Good

Possible Solutions:

Remove & Replace Detectable Warning System. Remove & Replace Gutter.
