Access Compliance Report

Public Rights-of-Way

(Island Curb Cuts)

Intersection ID: 10036062	Main Street: RIVERGATE_PY	Cross Street: N/A	Location: NW
ADA ID: B782F7C39E78	Curb Cut Type: MedianRefuge2	Initial Pass/Fail: Fail	Overall Compliance: No
Codes/Mitigation Info/Possible Solution		Field Measurements/Component Compliance

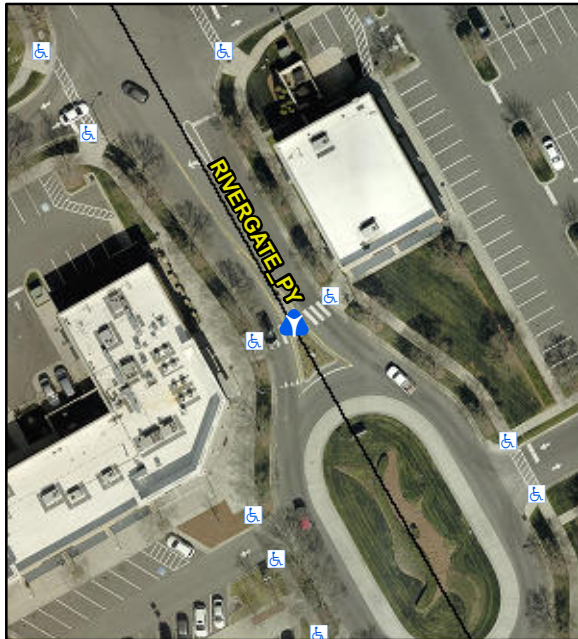
Compliance	Description	Data	Compliance	Description	Data
No	Refuge 1 Length (In)	28.0	N/A	Gutter 1 Ponding?	N/A
No	Refuge 1 Width (In)	51.0	N/A	Gutter 1 Lip Ht (In)	N/A
Yes	Refuge 1 Slope (%)	1.0	N/A	Gutter 1 Slope (%)	N/A
Yes	Refuge 1 X Slope (%)	2.4	N/A	Gutter 1 X Slope (%)	N/A
N/A	Painted X Walk1?	Yes	N/A	DWS 1 Provided?	N/A
N/A	X Walk 1 Direction	To NE	N/A	DWS 1 Contrast?	N/A
N/A	X Walk 1 Width (In)	120.0	N/A	DWS 1 Length (In)	N/A
N/A	Road 1 Slope (%)	1.1	N/A	DWS 1 Full Width?	N/A
N/A	Road 1 X Slope (%)	1.4	N/A	DWS 1 Offset (In)	N/A
No	Refuge 2 Length (In)	28.0	N/A	Gutter 2 Ponding?	N/A
No	Refuge 2 Width (In)	51.0	N/A	Gutter 2 Lip Ht (In)	N/A
Yes	Refuge 2 Slope (%)	2.3	N/A	Gutter 2 Slope (%)	N/A
Yes	Refuge 2 X Slope (%)	1.8	N/A	Gutter 2 X Slope (%)	N/A
N/A	Painted X Walk2?	Yes	N/A	DWS 2 Provided?	N/A
N/A	X Walk 2 Direction	To SW	N/A	DWS 2 Contrast?	N/A
N/A	X Walk 2 Width (In)	120.0	N/A	DWS 2 Length (In)	N/A

Remove & Replace Entire Refuge.
