# Access Compliance Report

## Public Rights-of-Way

### (Island Curb Cuts)

Intersection ID: 18567	Main Street: MICHAEL_BAKER_PL	Cross Street: RUNNYMEDE_LN	Location: E
ADA ID: B8F41101EE0A	Curb Cut Type: MedianRefuge2	Initial Pass/Fail: Fail	Overall Compliance: No
Codes/Mitigation Info/Possible Solution		Field Measurements/Component Compliance

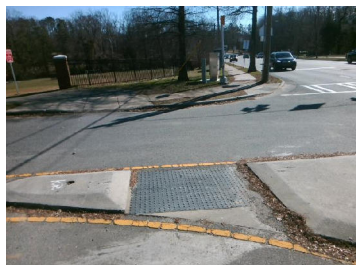
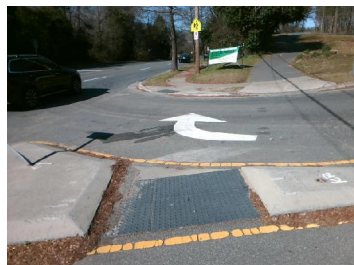
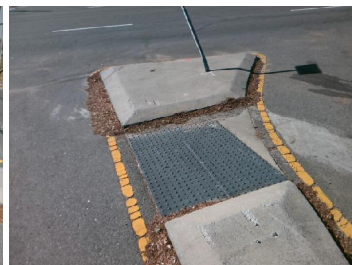
Compliance	Description	Data	Compliance	Description	Data
No	Refuge 1 Length (In)	24.0	N/A	Gutter 1 Ponding?	N/A
Yes	Refuge 1 Width (In)	74.0	N/A	Gutter 1 Lip Ht (In)	N/A
Yes	Refuge 1 Slope (%)	1.4	N/A	Gutter 1 Slope (%)	N/A
No	Refuge 1 X Slope (%)	6.8	N/A	Gutter 1 X Slope (%)	N/A
N/A	Painted X Walk1?	No	N/A	DWS 1 Provided?	N/A
N/A	X Walk 1 Direction	To S	N/A	DWS 1 Contrast?	N/A
N/A	X Walk 1 Width (In)	N/A	N/A	DWS 1 Length (In)	N/A
N/A	Road 1 Slope (%)	5.5	N/A	DWS 1 Full Width?	N/A
N/A	Road 1 X Slope (%)	3.1	N/A	DWS 1 Offset (In)	N/A
No	Refuge 2 Length (In)	24.0	N/A	Gutter 2 Ponding?	N/A
Yes	Refuge 2 Width (In)	74.0	N/A	Gutter 2 Lip Ht (In)	N/A
Yes	Refuge 2 Slope (%)	1.1	N/A	Gutter 2 Slope (%)	N/A
No	Refuge 2 X Slope (%)	6.8	N/A	Gutter 2 X Slope (%)	N/A
N/A	Painted X Walk2?	No	N/A	DWS 2 Provided?	N/A
N/A	X Walk 2 Direction	To N	N/A	DWS 2 Contrast?	N/A
N/A	X Walk 2 Width (In)	N/A	N/A	DWS 2 Length (In)	N/A
N/A	Road 2 Slope (%)	5.2	N/A	DWS 2 Full Width?	N/A

N/A	Road 2 X Slope (%)	4.0	N/A	DWS 2 Offset (In)	N/A
N/A	Refuge 3 Length (in)	N/A	N/A	Gutter 3 Ponding?	N/A
N/A	Refuge 3 Width (in)	N/A	N/A	Gutter 3 Lip Ht (in)	N/A
N/A	Refuge 3 Slope (%)	N/A	N/A	Gutter 3 Slope (%)	N/A
N/A	Refuge 3 XSlope (%)	N/A	N/A	Gutter 3 XSlope (%)	N/A
N/A	Painted X Walk3?	N/A	N/A	DWS 3 Provided?	N/A
N/A	X Walk 3 Direction	N/A	N/A	DWS 3 Contrast?	N/A
N/A	X Walk 3 Width (in)	N/A	N/A	DWS 3 Length (in)	N/A
N/A	Road 3 Slope (%)	N/A	N/A	DWS 3 Full Width?	N/A
N/A	Road 3 XSlope (%)	N/A	N/A	DWS 3 Offset (in)	N/A
Yes	Any Obstructions?	N/A	N/A	Storm Grate/Utility Hazard?	N/A
N/A	Obstruction Type		N/A	Storm Grate/Utility Type	
		N/A			N/A
N/A	Surface Condition	Good

**Remove & Replace Entire Refuge.**

**\$ 3000.00**
