Access Compliance Report

Public Rights-of-Way

(Island Curb Cuts)

Intersection ID: 5600	Main Street: N_TRYON_ST	Cross Street: J_M_KEYNES_DR	Location: S
ADA ID: BBD4F4CA01D3	Curb Cut Type: MedianRefuge2	Initial Pass/Fail: Fail	Overall Compliance: No
Severity Score: 0			
Codes/Mitigation Info/Possible Solution		Field Measurements/Component Compliance

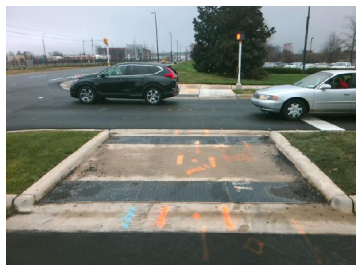
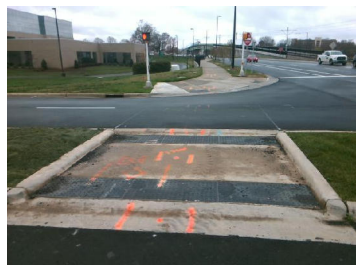
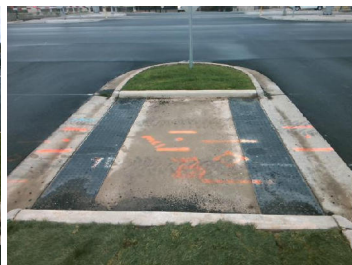
RECENTLY REPAVED-NO CROSSWALKS

Remove & Replace Entire Refuge.
