Access Compliance Report

Public Rights-of-Way

(Island Curb Cuts)

Intersection ID: 10011612	Main Street: UNIVERSITY_CITY_BV	Cross Street: N/A	Location: E
ADA ID: BC37E7A8A43E	Curb Cut Type: MedianRefuge2	Initial Pass/Fail: Pass	Overall Compliance: No
			Severity Score: 7.5

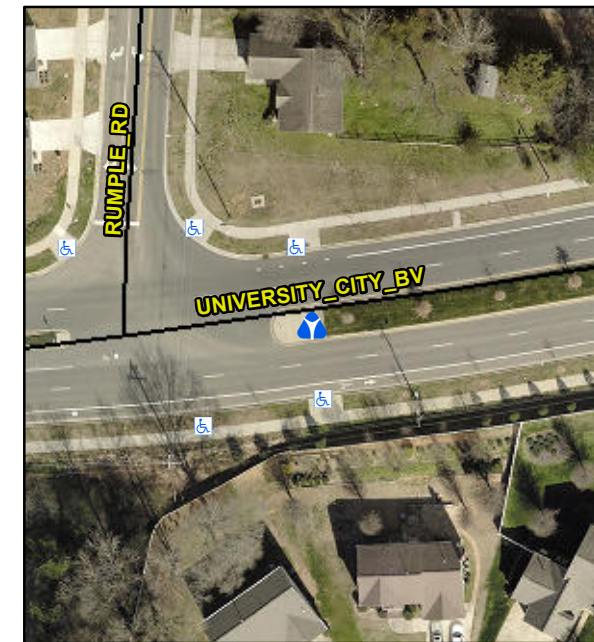
Compliance	Description	Data	Compliance	Description	Data
Yes	Refuge 1 Length (In)	94.0	No	Gutter 1 Ponding?	Yes
Yes	Refuge 1 Width (In)	94.0	No	Gutter 1 Lip Ht (In)	0.5
Yes	Refuge 1 Slope (%)	0.3	Yes	Gutter 1 Slope (%)	3.4
Yes	Refuge 1 X Slope (%)	0.6	Yes	Gutter 1 X Slope (%)	0.3
N/A	Painted X Walk1?	No	Yes	DWS 1 Provided?	Yes
N/A	X Walk 1 Direction	To N	Yes	DWS 1 Contrast?	Yes
N/A	X Walk 1 Width (In)	N/A	Yes	DWS 1 Length (In)	24.0
N/A	Road 1 Slope (%)	0.1	Yes	DWS 1 Full Width?	Yes
N/A	Road 1 X Slope (%)	1.4	No	DWS 1 Offset (In)	3.0
Yes	Refuge 2 Length (In)	97.5	No	Gutter 2 Ponding?	Yes
Yes	Refuge 2 Width (In)	95.0	No	Gutter 2 Lip Ht (In)	0.5
Yes	Refuge 2 Slope (%)	1.2	Yes	Gutter 2 Slope (%)	3.9
Yes	Refuge 2 X Slope (%)	0.1	Yes	Gutter 2 X Slope (%)	1.0
N/A	Painted X Walk2?	No	Yes	DWS 2 Provided?	Yes
N/A	X Walk 2 Direction	To SW	Yes	DWS 2 Contrast?	Yes
N/A	X Walk 2 Width (In)	N/A	Yes	DWS 2 Length (In)	24.0

N/A	Road 2 Slope (%)	1.0	Yes	DWS 2 Full Width?	Yes
N/A	Road 2 X Slope (%)	1.5	No	DWS 2 Offset (In)	3.5
N/A	Refuge 3 Length (in)	N/A	N/A	Gutter 3 Ponding?	No
N/A	Refuge 3 Width (in)	N/A	N/A	Gutter 3 Lip Ht (in)	N/A
N/A	Refuge 3 Slope (%)	N/A	N/A	Gutter 3 Slope (%)	N/A
N/A	Refuge 3 XSlope (%)	N/A	N/A	Gutter 3 XSlope (%)	N/A
N/A	Painted X Walk3?	No	N/A	DWS 3 Provided?	N/A
N/A	X Walk 3 Direction	N/A	N/A	DWS 3 Contrast?	N/A
N/A	X Walk 3 Width (in)	N/A	N/A	DWS 3 Length (in)	N/A
N/A	Road 3 Slope (%)	N/A	N/A	DWS 3 Full Width?	N/A
N/A	Road 3 XSlope (%)	N/A	N/A	DWS 3 Offset (in)	N/A
Yes	Any Obstructions?	No	N/A	Storm Grate/Utility Hazard?	No
N/A	Obstruction Type		N/A	Storm Grate/Utility Type	
		N/A			N/A
N/A	Surface Condition	Good

Remove & Replace Detectable Warning System. Grind Gutter Lip.
