Access Compliance Report

Public Rights-of-Way

(Island Curb Cuts)

Intersection ID: 14294	Main Street: EAST_BV	Cross Street: EUCLID_AV	Location: SE
ADA ID: BC76BD3ABFAD	Curb Cut Type: MedianRefuge2	Initial Pass/Fail: Pass	Overall Compliance: No
Severity Score: 0.25			
Codes/Mitigation Info/Possible Solution		Field Measurements/Component Compliance

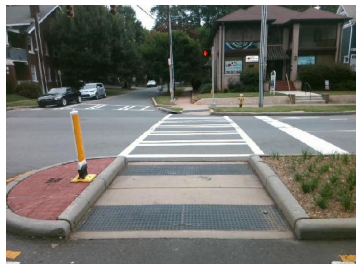
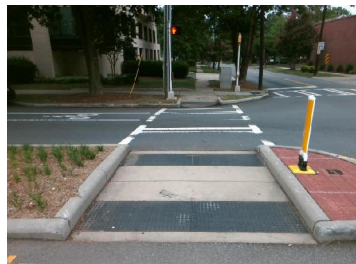
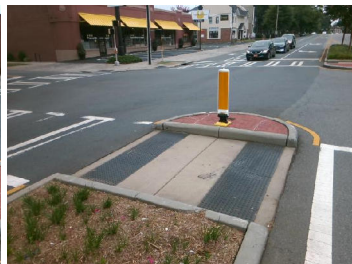
N/A	Road 2 Slope (%)	0.4	Yes	DWS 2 Full Width?	Yes
N/A	Road 2 X Slope (%)	1.0	No	DWS 2 Offset (In)	7.0
N/A	Refuge 3 Length (in)	N/A	N/A	Gutter 3 Ponding?	N/A
N/A	Refuge 3 Width (in)	N/A	N/A	Gutter 3 Lip Ht (in)	N/A
N/A	Refuge 3 Slope (%)	N/A	N/A	Gutter 3 Slope (%)	N/A
N/A	Refuge 3 XSlope (%)	N/A	N/A	Gutter 3 XSlope (%)	N/A
N/A	Painted X Walk3?	N/A	N/A	DWS 3 Provided?	N/A
N/A	X Walk 3 Direction	N/A	N/A	DWS 3 Contrast?	N/A
N/A	X Walk 3 Width (in)	N/A	N/A	DWS 3 Length (in)	N/A
N/A	Road 3 Slope (%)	N/A	N/A	DWS 3 Full Width?	N/A
N/A	Road 3 XSlope (%)	N/A	N/A	DWS 3 Offset (in)	N/A
Yes	Any Obstructions?	N/A	N/A	Storm Grate/Utility Hazard?	No
N/A	Obstruction Type		N/A	Storm Grate/Utility Type	
		N/A			N/A
N/A	Surface Condition	Good

Remove & Replace Detectable Warning System.
