# Access Compliance Report

## Public Rights-of-Way

### (Island Curb Cuts)

Intersection ID: 15542	Main Street: CLANTON_RD	Cross Street: N_CLANTON_TO_S_I-77_RA_NB	Location: NE
ADA ID: BD7FACF17AD6	Curb Cut Type: IslandRefuge3	Initial Pass/Fail: Fail	Overall Compliance: No
Severity Score: 35			
Codes/Mitigation Info/Possible Solution		Field Measurements/Component Compliance

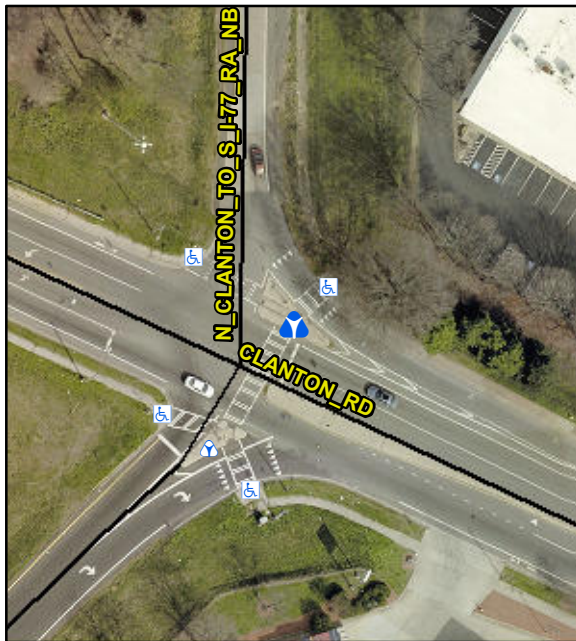
Compliance	Description	Data	Compliance	Description	Data
Yes	Refuge 1 Length (In)	32.0	N/A	Gutter 1 Ponding?	N/A
No	Refuge 1 Width (In)	59.0	N/A	Gutter 1 Lip Ht (In)	N/A
Yes	Refuge 1 Slope (%)	1.1	N/A	Gutter 1 Slope (%)	N/A
Yes	Refuge 1 X Slope (%)	3.0	N/A	Gutter 1 X Slope (%)	N/A
N/A	Painted X Walk1?	Yes	N/A	DWS 1 Provided?	N/A
N/A	X Walk 1 Direction	To NE	N/A	DWS 1 Contrast?	N/A
N/A	X Walk 1 Width (In)	111.0	N/A	DWS 1 Length (In)	N/A
N/A	Road 1 Slope (%)	1.5	N/A	DWS 1 Full Width?	N/A
N/A	Road 1 X Slope (%)	0.1	N/A	DWS 1 Offset (In)	N/A
Yes	Refuge 2 Length (In)	52.0	N/A	Gutter 2 Ponding?	N/A
Yes	Refuge 2 Width (In)	60.0	N/A	Gutter 2 Lip Ht (In)	N/A
Yes	Refuge 2 Slope (%)	1.9	N/A	Gutter 2 Slope (%)	N/A
Yes	Refuge 2 X Slope (%)	0.0	N/A	Gutter 2 X Slope (%)	N/A
N/A	Painted X Walk2?	Yes	N/A	DWS 2 Provided?	N/A
N/A	X Walk 2 Direction	To SW	N/A	DWS 2 Contrast?	N/A
N/A	X Walk 2 Width (In)	111.0	N/A	DWS 2 Length (In)	N/A

N/A	Road 2 Slope (%)	0.8	N/A	DWS 2 Full Width?	N/A
N/A	Road 2 X Slope (%)	2.9	N/A	DWS 2 Offset (In)	N/A
Yes	Refuge 3 Length (in)	187.0	N/A	Gutter 3 Ponding?	N/A
Yes	Refuge 3 Width (in)	60.0	N/A	Gutter 3 Lip Ht (in)	N/A
Yes	Refuge 3 Slope (%)	0.7	N/A	Gutter 3 Slope (%)	N/A
Yes	Refuge 3 XSlope (%)	3.8	N/A	Gutter 3 XSlope (%)	N/A
N/A	Painted X Walk3?	Yes	N/A	DWS 3 Provided?	N/A
N/A	X Walk 3 Direction	To NW	N/A	DWS 3 Contrast?	N/A
N/A	X Walk 3 Width (in)	109.0	N/A	DWS 3 Length (in)	N/A
N/A	Road 3 Slope (%)	2.2	N/A	DWS 3 Full Width?	N/A
N/A	Road 3 XSlope (%)	0.5	N/A	DWS 3 Offset (in)	N/A
Yes	Any Obstructions?	N/A	N/A	Storm Grate/Utility Hazard?	N/A
N/A	Obstruction Type		N/A	Storm Grate/Utility Type	
			N/A		N/A
N/A	Surface Condition	Good

**Remove & Replace Entire Refuge.**

**\$ 3000.00**
