# Access Compliance Report

## Public Rights-of-Way

### (Island Curb Cuts)

Intersection ID: 11331	Main Street: E_W_T_HARRIS_BV	Cross Street: MEADOW_ROSE_LN	Location: SW
ADA ID: BE31CE4E3D5F	Curb Cut Type: MedianRefuge2	Initial Pass/Fail: Pass	Overall Compliance: Yes
Codes/Mitigation Info/Possible Solution		Field Measurements/Component Compliance	
Severity Score: 0.25

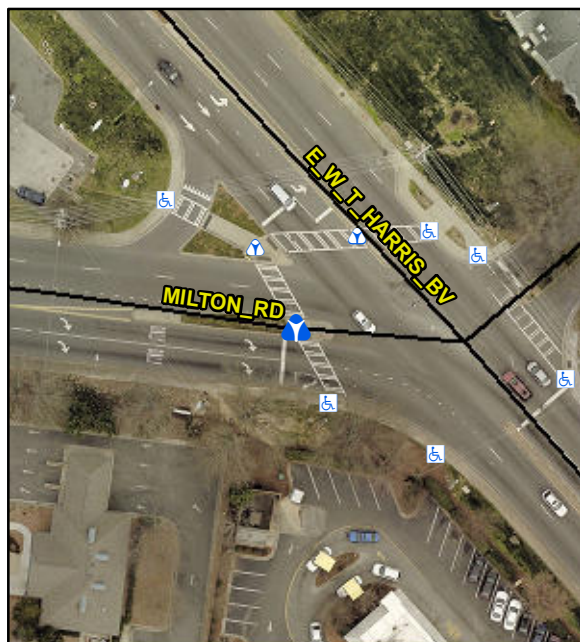
Compliance	Description	Data	Compliance	Description	Data
Yes	Refuge 1 Length (In)	56.0	Yes	Gutter 1 Ponding?	No
Yes	Refuge 1 Width (In)	112.0	Yes	Gutter 1 Lip Ht (In)	0.0
Yes	Refuge 1 Slope (%)	2.9	Yes	Gutter 1 Slope (%)	1.6
Yes	Refuge 1 X Slope (%)	1.2	Yes	Gutter 1 X Slope (%)	0.7
N/A	Painted X Walk1?	Yes	Yes	DWS 1 Provided?	Yes
N/A	X Walk 1 Direction	To NW	Yes	DWS 1 Contrast?	Yes
N/A	X Walk 1 Width (In)	113.0	Yes	DWS 1 Length (In)	24.0
N/A	Road 1 Slope (%)	0.5	Yes	DWS 1 Full Width?	Yes
N/A	Road 1 X Slope (%)	1.2	Yes	DWS 1 Offset (In)	0.0
Yes	Refuge 2 Length (In)	56.0	Yes	Gutter 2 Ponding?	No
Yes	Refuge 2 Width (In)	116.0	Yes	Gutter 2 Lip Ht (In)	0.0
Yes	Refuge 2 Slope (%)	4.9	Yes	Gutter 2 Slope (%)	3.3
Yes	Refuge 2 X Slope (%)	0.8	Yes	Gutter 2 X Slope (%)	1.4
N/A	Painted X Walk2?	Yes	Yes	DWS 2 Provided?	Yes
N/A	X Walk 2 Direction	To SE	Yes	DWS 2 Contrast?	Yes
N/A	X Walk 2 Width (In)	103.0	Yes	DWS 2 Length (In)	24.5

N/A	Road 2 Slope (%)	0.3	Yes	DWS 2 Full Width?	Yes
N/A	Road 2 X Slope (%)	2.7	Yes	DWS 2 Offset (In)	0.0
N/A	Refuge 3 Length (in)	N/A	N/A	Gutter 3 Ponding?	No
N/A	Refuge 3 Width (in)	N/A	N/A	Gutter 3 Lip Ht (in)	N/A
N/A	Refuge 3 Slope (%)	N/A	N/A	Gutter 3 Slope (%)	N/A
N/A	Refuge 3 XSlope (%)	N/A	N/A	Gutter 3 XSlope (%)	N/A
N/A	Painted X Walk3?	No	N/A	DWS 3 Provided?	N/A
N/A	X Walk 3 Direction	N/A	N/A	DWS 3 Contrast?	N/A
N/A	X Walk 3 Width (in)	N/A	N/A	DWS 3 Length (in)	N/A
N/A	Road 3 Slope (%)	N/A	N/A	DWS 3 Full Width?	N/A
N/A	Road 3 XSlope (%)	N/A	N/A	DWS 3 Offset (in)	N/A
Yes	Any Obstructions?	No	N/A	Storm Grate/Utility Hazard?	No
N/A	Obstruction Type		N/A	Storm Grate/Utility Type	
		N/A			N/A
N/A	Surface Condition	Good

N/A
