# Access Compliance Report

## Public Rights-of-Way

### (Island Curb Cuts)

Intersection ID: 14648	Main Street: EAST_BV	Cross Street: LENNOX_AV	Location: NW
ADA ID: BEA91225F03D	Curb Cut Type: MedianRefuge2	Initial Pass/Fail: Fail	Overall Compliance: No
Severity Score: 1.25			
Codes/Mitigation Info/Possible Solution		Field Measurements/Component Compliance

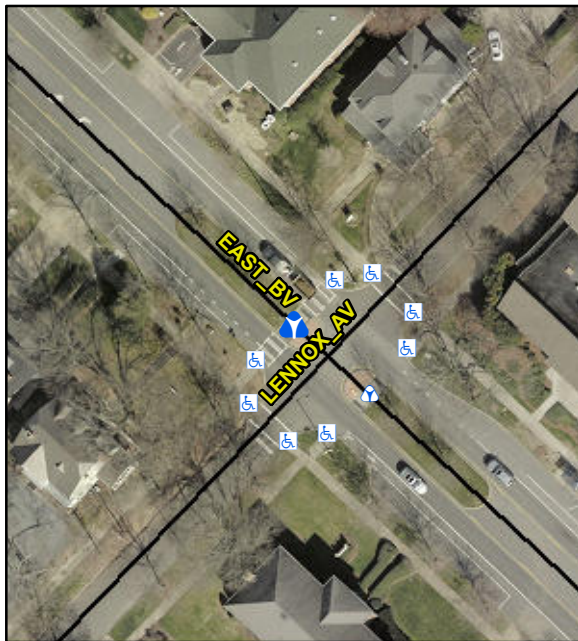
Compliance	Description	Data	Compliance	Description	Data
Yes	Refuge 1 Length (In)	114.0	N/A	Gutter 1 Ponding?	N/A
Yes	Refuge 1 Width (In)	97.0	N/A	Gutter 1 Lip Ht (In)	N/A
Yes	Refuge 1 Slope (%)	3.1	N/A	Gutter 1 Slope (%)	N/A
Yes	Refuge 1 X Slope (%)	2.4	N/A	Gutter 1 X Slope (%)	N/A
N/A	Painted X Walk1?	Yes	N/A	DWS 1 Provided?	N/A
N/A	X Walk 1 Direction	To SW	N/A	DWS 1 Contrast?	N/A
N/A	X Walk 1 Width (In)	112.0	N/A	DWS 1 Length (In)	N/A
N/A	Road 1 Slope (%)	1.4	N/A	DWS 1 Full Width?	N/A
N/A	Road 1 X Slope (%)	2.5	N/A	DWS 1 Offset (In)	N/A
Yes	Refuge 2 Length (In)	114.0	N/A	Gutter 2 Ponding?	N/A
Yes	Refuge 2 Width (In)	97.0	N/A	Gutter 2 Lip Ht (In)	N/A
Yes	Refuge 2 Slope (%)	0.6	N/A	Gutter 2 Slope (%)	N/A
Yes	Refuge 2 X Slope (%)	1.2	N/A	Gutter 2 X Slope (%)	N/A
N/A	Painted X Walk2?	Yes	N/A	DWS 2 Provided?	N/A
N/A	X Walk 2 Direction	To NE	N/A	DWS 2 Contrast?	N/A
N/A	X Walk 2 Width (In)	110.0	N/A	DWS 2 Length (In)	N/A

N/A	Road 2 Slope (%)	1.4	N/A	DWS 2 Full Width?	N/A
N/A	Road 2 X Slope (%)	2.3	N/A	DWS 2 Offset (In)	N/A
N/A	Refuge 3 Length (in)	N/A	N/A	Gutter 3 Ponding?	N/A
N/A	Refuge 3 Width (in)	N/A	N/A	Gutter 3 Lip Ht (in)	N/A
N/A	Refuge 3 Slope (%)	N/A	N/A	Gutter 3 Slope (%)	N/A
N/A	Refuge 3 XSlope (%)	N/A	N/A	Gutter 3 XSlope (%)	N/A
N/A	Painted X Walk3?	N/A	N/A	DWS 3 Provided?	N/A
N/A	X Walk 3 Direction	N/A	N/A	DWS 3 Contrast?	N/A
N/A	X Walk 3 Width (in)	N/A	N/A	DWS 3 Length (in)	N/A
N/A	Road 3 Slope (%)	N/A	N/A	DWS 3 Full Width?	N/A
N/A	Road 3 XSlope (%)	N/A	N/A	DWS 3 Offset (in)	N/A
Yes	Any Obstructions?	N/A	N/A	Storm Grate/Utility Hazard?	N/A
N/A	Obstruction Type		N/A	Storm Grate/Utility Type	
		N/A			N/A
N/A	Surface Condition	Good

**Remove & Replace Entire Refuge.**
