# Access Compliance Report

## Public Rights-of-Way

### (Island Curb Cuts)

Intersection ID: 2601	Main Street: PROSPERITY_CHURCH_RD	Cross Street: EASTFIELD_RD	Location: NE
ADA ID: BF33ED07380E	Curb Cut Type: MedianRefuge2	Initial Pass/Fail: Pass	Overall Compliance: No
Codes/Mitigation Info/Possible Solution		Field Measurements/Component Compliance	
Severity Score: 15

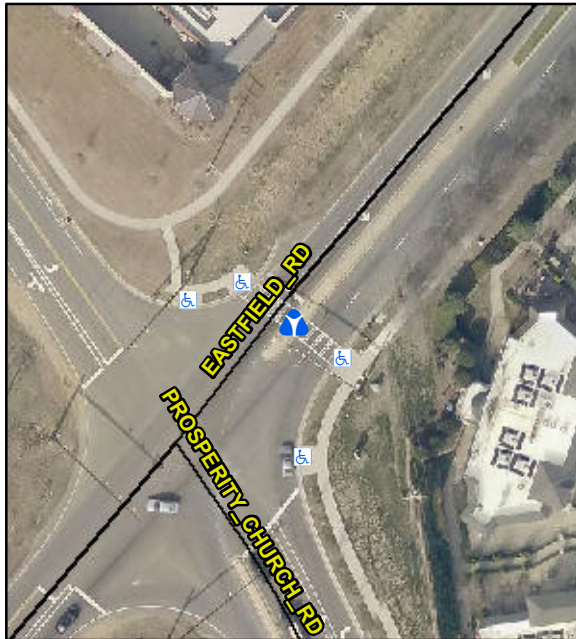
Compliance	Description	Data	Compliance	Description	Data
No	Refuge 1 Length (In)	N/A	Yes	Gutter 1 Ponding?	No
Yes	Refuge 1 Width (In)	119.0	No	Gutter 1 Lip Ht (In)	0.25
Yes	Refuge 1 Slope (%)	1.4	Yes	Gutter 1 Slope (%)	1.6
Yes	Refuge 1 X Slope (%)	1.1	Yes	Gutter 1 X Slope (%)	1.0
N/A	Painted X Walk1?	Yes	No	DWS 1 Provided?	Yes
N/A	X Walk 1 Direction	To NW	N/A	DWS 1 Contrast?	Yes
N/A	X Walk 1 Width (In)	118.0	N/A	DWS 1 Length (In)	24.0
N/A	Road 1 Slope (%)	1.4	N/A	DWS 1 Full Width?	No
N/A	Road 1 X Slope (%)	0.2	N/A	DWS 1 Offset (In)	0.0
No	Refuge 2 Length (In)	36.0	Yes	Gutter 2 Ponding?	No
Yes	Refuge 2 Width (In)	119.0	No	Gutter 2 Lip Ht (In)	0.25
Yes	Refuge 2 Slope (%)	1.3	No	Gutter 2 Slope (%)	6.7
Yes	Refuge 2 X Slope (%)	1.4	Yes	Gutter 2 X Slope (%)	1.2
N/A	Painted X Walk2?	Yes	No	DWS 2 Provided?	Yes
N/A	X Walk 2 Direction	To SE	N/A	DWS 2 Contrast?	Yes
N/A	X Walk 2 Width (In)	113.0	N/A	DWS 2 Length (In)	24.0

N/A	Road 2 Slope (%)	0.2	N/A	DWS 2 Full Width?	No
N/A	Road 2 X Slope (%)	7.5	N/A	DWS 2 Offset (In)	0.0
N/A	Refuge 3 Length (in)	N/A	N/A	Gutter 3 Ponding?	No
N/A	Refuge 3 Width (in)	N/A	N/A	Gutter 3 Lip Ht (in)	N/A
N/A	Refuge 3 Slope (%)	N/A	N/A	Gutter 3 Slope (%)	N/A
N/A	Refuge 3 XSlope (%)	N/A	N/A	Gutter 3 XSlope (%)	N/A
N/A	Painted X Walk3?	No	N/A	DWS 3 Provided?	N/A
N/A	X Walk 3 Direction	N/A	N/A	DWS 3 Contrast?	N/A
N/A	X Walk 3 Width (in)	N/A	N/A	DWS 3 Length (in)	N/A
N/A	Road 3 Slope (%)	N/A	N/A	DWS 3 Full Width?	N/A
N/A	Road 3 XSlope (%)	N/A	N/A	DWS 3 Offset (in)	N/A
Yes	Any Obstructions?	No	N/A	Storm Grate/Utility Hazard?	No
N/A	Obstruction Type		N/A	Storm Grate/Utility Type	
		N/A			N/A
N/A	Surface Condition	Good

**Remove & Replace Entire Refuge.  
Grind Gutter Lip. Remove & Replace  
Gutter.**
