Access Compliance Report

Public Rights-of-Way

(Island Curb Cuts)

Intersection ID: 27397	Main Street: ELM_LN	Cross Street: BALLANTYNE_COMMONS_PY	Location:	W
ADA ID: BF6F919EA523	Curb Cut Type: MedianRefuge2	Initial Pass/Fail: Fail	Overall Compliance: No	Severity Score: 0
Codes/Mitigation Info/Possible Solution		Field Measurements/Component Compliance

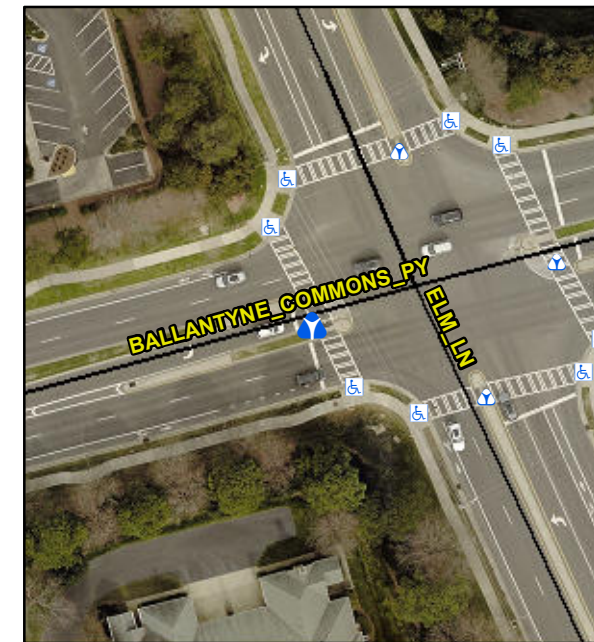
Compliance	Description	Data	Compliance	Description	Data
Yes	Refuge 1 Length (In)	38.5	N/A	Gutter 1 Ponding?	N/A
Yes	Refuge 1 Width (In)	98.0	N/A	Gutter 1 Lip Ht (In)	N/A
Yes	Refuge 1 Slope (%)	1.8	N/A	Gutter 1 Slope (%)	N/A
Yes	Refuge 1 X Slope (%)	2.2	N/A	Gutter 1 X Slope (%)	N/A
N/A	Painted X Walk1?	Yes	N/A	DWS 1 Provided?	N/A
N/A	X Walk 1 Direction	To NW	N/A	DWS 1 Contrast?	N/A
N/A	X Walk 1 Width (In)	114.0	N/A	DWS 1 Length (In)	N/A
N/A	Road 1 Slope (%)	0.6	N/A	DWS 1 Full Width?	N/A
N/A	Road 1 X Slope (%)	0.0	N/A	DWS 1 Offset (In)	N/A
Yes	Refuge 2 Length (In)	38.5	N/A	Gutter 2 Ponding?	N/A
Yes	Refuge 2 Width (In)	98.0	N/A	Gutter 2 Lip Ht (In)	N/A
Yes	Refuge 2 Slope (%)	0.3	N/A	Gutter 2 Slope (%)	N/A
Yes	Refuge 2 X Slope (%)	2.0	N/A	Gutter 2 X Slope (%)	N/A
N/A	Painted X Walk2?	Yes	N/A	DWS 2 Provided?	N/A
N/A	X Walk 2 Direction	To SE	N/A	DWS 2 Contrast?	N/A
N/A	X Walk 2 Width (In)	115.0	N/A	DWS 2 Length (In)	N/A

Remove & Replace Entire Refuge.
