Access Compliance Report

Public Rights-of-Way

(Island Curb Cuts)

| Intersection ID: 50119 | Main Street: PARK_SOUTH_STATION_BV | Cross Street: PARK_ROYAL_AV | Location: NE |

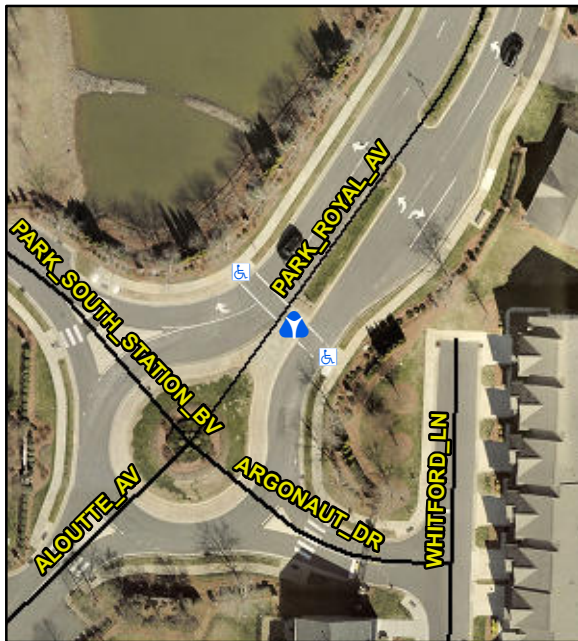
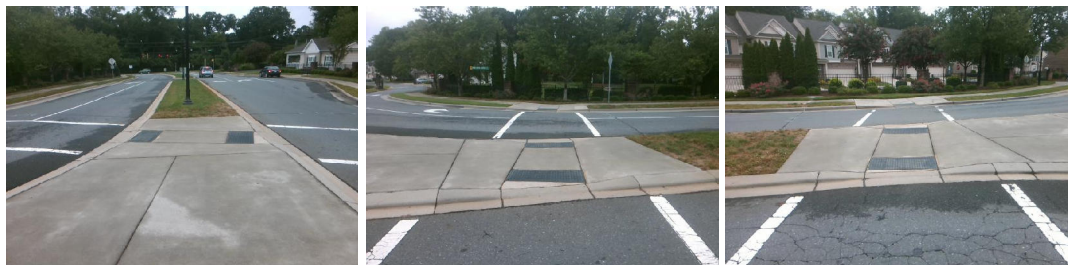
| ADA ID: BF7E8F40501E | Curb Cut Type: MedianRefuge2 | Initial Pass/Fail: Fail | Overall Compliance: No |

| Compliance | Description | Data | Compliance | Description | Data |
|---|---|---|---|---|---|
| No | Refuge 1 Width (In) | 46.5 | N/A | Gutter 1 Lip Ht (In) | N/A |
| No | Refuge 1 Slope (%) | 5.4 | N/A | Gutter 1 Slope (%) | N/A |
| No | Refuge 2 Width (In) | 46.5 | N/A | Gutter 2 Lip Ht (In) | N/A |

Remove & Replace Entire Refuge.
