# Access Compliance Report

## Public Rights-of-Way

### (Island Curb Cuts)

Intersection ID: 43922	Main Street: NORTH_COMMUNITY_HOUSE_RD	Cross Street: JOHNSTON_RD	Location: SW
ADA ID: BF94F1EDA08F	Curb Cut Type: MedianRefuge2	Initial Pass/Fail: Fail	Overall Compliance: No
Severity Score: 1.25			
Codes/Mitigation Info/Possible Solution		Field Measurements/Component Compliance

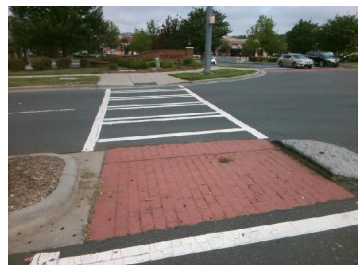
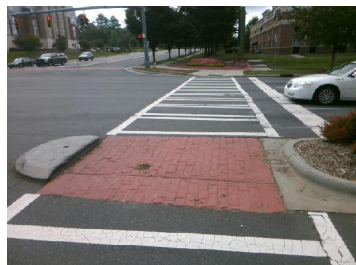
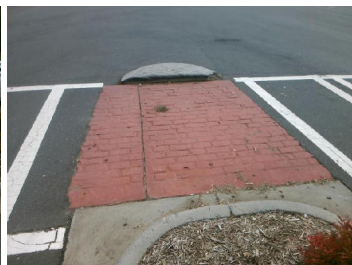
Compliance	Description	Data	Compliance	Description	Data
Yes	Refuge 1 Length (In)	46.5	N/A	Gutter 1 Ponding?	N/A
Yes	Refuge 1 Width (In)	118.0	N/A	Gutter 1 Lip Ht (In)	N/A
Yes	Refuge 1 Slope (%)	3.1	N/A	Gutter 1 Slope (%)	N/A
Yes	Refuge 1 X Slope (%)	3.3	N/A	Gutter 1 X Slope (%)	N/A
N/A	Painted X Walk1?	Yes	N/A	DWS 1 Provided?	N/A
N/A	X Walk 1 Direction	To NW	N/A	DWS 1 Contrast?	N/A
N/A	X Walk 1 Width (In)	118.0	N/A	DWS 1 Length (In)	N/A
N/A	Road 1 Slope (%)	1.6	N/A	DWS 1 Full Width?	N/A
N/A	Road 1 X Slope (%)	1.9	N/A	DWS 1 Offset (In)	N/A
Yes	Refuge 2 Length (In)	46.5	N/A	Gutter 2 Ponding?	N/A
Yes	Refuge 2 Width (In)	118.0	N/A	Gutter 2 Lip Ht (In)	N/A
Yes	Refuge 2 Slope (%)	2.3	N/A	Gutter 2 Slope (%)	N/A
Yes	Refuge 2 X Slope (%)	2.0	N/A	Gutter 2 X Slope (%)	N/A
N/A	Painted X Walk2?	Yes	N/A	DWS 2 Provided?	N/A
N/A	X Walk 2 Direction	To SE	N/A	DWS 2 Contrast?	N/A
N/A	X Walk 2 Width (In)	118.0	N/A	DWS 2 Length (In)	N/A

N/A	Road 2 Slope (%)	1.6	N/A	DWS 2 Full Width?	N/A
N/A	Road 2 X Slope (%)	1.2	N/A	DWS 2 Offset (In)	N/A
N/A	Refuge 3 Length (in)	N/A	N/A	Gutter 3 Ponding?	N/A
N/A	Refuge 3 Width (in)	N/A	N/A	Gutter 3 Lip Ht (in)	N/A
N/A	Refuge 3 Slope (%)	N/A	N/A	Gutter 3 Slope (%)	N/A
N/A	Refuge 3 XSlope (%)	N/A	N/A	Gutter 3 XSlope (%)	N/A
N/A	Painted X Walk3?	N/A	N/A	DWS 3 Provided?	N/A
N/A	X Walk 3 Direction	N/A	N/A	DWS 3 Contrast?	N/A
N/A	X Walk 3 Width (in)	N/A	N/A	DWS 3 Length (in)	N/A
N/A	Road 3 Slope (%)	N/A	N/A	DWS 3 Full Width?	N/A
N/A	Road 3 XSlope (%)	N/A	N/A	DWS 3 Offset (in)	N/A
Yes	Any Obstructions?	N/A	N/A	Storm Grate/Utility Hazard?	N/A
N/A	Obstruction Type		N/A	Storm Grate/Utility Type	
		N/A			N/A
N/A	Surface Condition	Good

**Remove & Replace Entire Refuge.**

Total Cost: \$ 3000.00
