# Access Compliance Report

## Public Rights-of-Way

### (Island Curb Cuts)

Intersection ID: 11979	Main Street: N_CALDWELL_ST	Cross Street: E_12TH_ST	Location: N
ADA ID: BFDFCD1DF20A	Curb Cut Type: MedianRefuge2	Initial Pass/Fail: Fail	Overall Compliance: No
Severity Score: 1.25			
Codes/Mitigation Info/Possible Solution		Field Measurements/Component Compliance

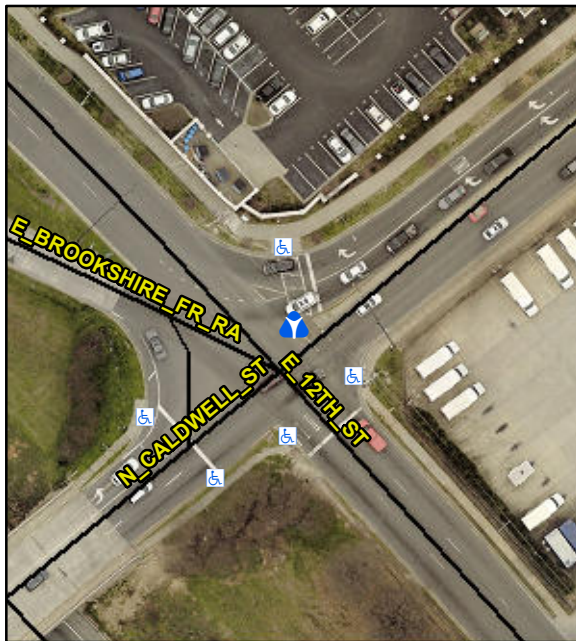
Compliance	Description	Data	Compliance	Description	Data
Yes	Refuge 1 Length (In)	45.0	N/A	Gutter 1 Ponding?	N/A
Yes	Refuge 1 Width (In)	93.5	N/A	Gutter 1 Lip Ht (In)	N/A
Yes	Refuge 1 Slope (%)	2.8	N/A	Gutter 1 Slope (%)	N/A
Yes	Refuge 1 X Slope (%)	2.3	N/A	Gutter 1 X Slope (%)	N/A
N/A	Painted X Walk1?	Yes	N/A	DWS 1 Provided?	N/A
N/A	X Walk 1 Direction	To N	N/A	DWS 1 Contrast?	N/A
N/A	X Walk 1 Width (In)	110.0	N/A	DWS 1 Length (In)	N/A
N/A	Road 1 Slope (%)	1.6	N/A	DWS 1 Full Width?	N/A
N/A	Road 1 X Slope (%)	1.7	N/A	DWS 1 Offset (In)	N/A
Yes	Refuge 2 Length (In)	45.0	N/A	Gutter 2 Ponding?	N/A
Yes	Refuge 2 Width (In)	93.5	N/A	Gutter 2 Lip Ht (In)	N/A
Yes	Refuge 2 Slope (%)	0.8	N/A	Gutter 2 Slope (%)	N/A
Yes	Refuge 2 X Slope (%)	0.7	N/A	Gutter 2 X Slope (%)	N/A
N/A	Painted X Walk2?	Yes	N/A	DWS 2 Provided?	N/A
N/A	X Walk 2 Direction	To SE	N/A	DWS 2 Contrast?	N/A
N/A	X Walk 2 Width (In)	98.0	N/A	DWS 2 Length (In)	N/A

N/A	Road 2 Slope (%)	1.7	N/A	DWS 2 Full Width?	N/A
N/A	Road 2 X Slope (%)	1.8	N/A	DWS 2 Offset (In)	N/A
N/A	Refuge 3 Length (in)	N/A	N/A	Gutter 3 Ponding?	N/A
N/A	Refuge 3 Width (in)	N/A	N/A	Gutter 3 Lip Ht (in)	N/A
N/A	Refuge 3 Slope (%)	N/A	N/A	Gutter 3 Slope (%)	N/A
N/A	Refuge 3 XSlope (%)	N/A	N/A	Gutter 3 XSlope (%)	N/A
N/A	Painted X Walk3?	N/A	N/A	DWS 3 Provided?	N/A
N/A	X Walk 3 Direction	N/A	N/A	DWS 3 Contrast?	N/A
N/A	X Walk 3 Width (in)	N/A	N/A	DWS 3 Length (in)	N/A
N/A	Road 3 Slope (%)	N/A	N/A	DWS 3 Full Width?	N/A
N/A	Road 3 XSlope (%)	N/A	N/A	DWS 3 Offset (in)	N/A
Yes	Any Obstructions?	N/A	N/A	Storm Grate/Utility Hazard?	N/A
N/A	Obstruction Type		N/A	Storm Grate/Utility Type	
		N/A			N/A
N/A	Surface Condition	Good

**Remove & Replace Entire Refuge.**

Total Cost: \$ 3000.00
