Access Compliance Report Public Rights-of-Way (Island Curb Cuts)

Intersection ID: 43406 Main Street: ARCHDALE_DR Cross Street: PARK_ROYAL_AV Location: S

ADA ID: C0CBA4D027FA Curb Cut Type: MedianRefuge2 Initial Pass/Fail: Fail Overall Compliance: No Severity Score: 1.25

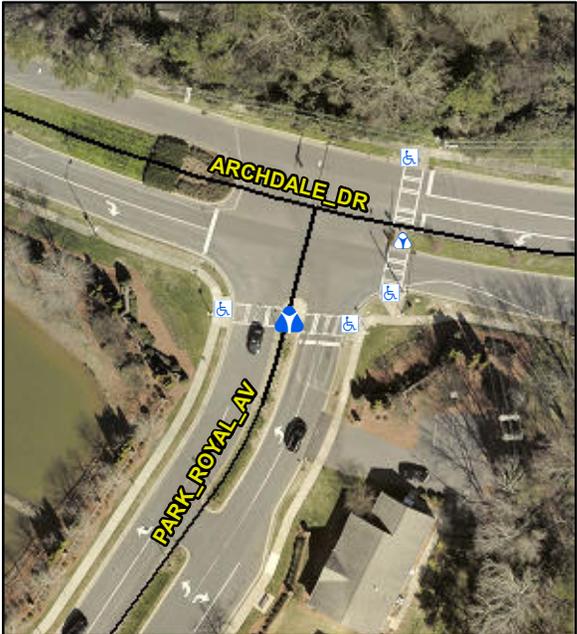
Compliance	Description	Data	Compliance	Description	Data
Yes	Refuge 1 Length (In)	78.0	N/A	Gutter 1 Ponding?	N/A
Yes	Refuge 1 Width (In)	115.0	N/A	Gutter 1 Lip Ht (In)	N/A
Yes	Refuge 1 Slope (%)	1.7	N/A	Gutter 1 Slope (%)	N/A
Yes	Refuge 1 X Slope (%)	3.5	N/A	Gutter 1 X Slope (%)	N/A
N/A	Painted X Walk1?	Yes	N/A	DWS 1 Provided?	N/A
N/A	X Walk 1 Direction	To E	N/A	DWS 1 Contrast?	N/A
N/A	X Walk 1 Width (In)	108.0	N/A	DWS 1 Length (In)	N/A
N/A	Road 1 Slope (%)	4.0	N/A	DWS 1 Full Width?	N/A
N/A	Road 1 X Slope (%)	0.3	N/A	DWS 1 Offset (In)	N/A
Yes	Refuge 2 Length (In)	78.0	N/A	Gutter 2 Ponding?	N/A
Yes	Refuge 2 Width (In)	115.0	N/A	Gutter 2 Lip Ht (In)	N/A
Yes	Refuge 2 Slope (%)	2.2	N/A	Gutter 2 Slope (%)	N/A
Yes	Refuge 2 X Slope (%)	2.7	N/A	Gutter 2 X Slope (%)	N/A
N/A	Painted X Walk2?	Yes	N/A	DWS 2 Provided?	N/A
N/A	X Walk 2 Direction	To W	N/A	DWS 2 Contrast?	N/A
N/A	X Walk 2 Width (In)	108.0	N/A	DWS 2 Length (In)	N/A

N/A	Road 2 Slope (%)	2.4	N/A	DWS 2 Full Width?	N/A
N/A	Road 2 X Slope (%)	0.3	N/A	DWS 2 Offset (In)	N/A
N/A	Refuge 3 Length (in)	N/A	N/A	Gutter 3 Ponding?	N/A
N/A	Refuge 3 Width (in)	N/A	N/A	Gutter 3 Lip Ht (in)	N/A
N/A	Refuge 3 Slope (%)	N/A	N/A	Gutter 3 Slope (%)	N/A
N/A	Refuge 3 XSlope (%)	N/A	N/A	Gutter 3 XSlope (%)	N/A
N/A	Painted X Walk3?	N/A	N/A	DWS 3 Provided?	N/A
N/A	X Walk 3 Direction	N/A	N/A	DWS 3 Contrast?	N/A
N/A	X Walk 3 Width (in)	N/A	N/A	DWS 3 Length (in)	N/A
N/A	Road 3 Slope (%)	N/A	N/A	DWS 3 Full Width?	N/A
N/A	Road 3 XSlope (%)	N/A	N/A	DWS 3 Offset (in)	N/A
Yes	Any Obstructions?	N/A	N/A	Storm Grate/Utility Hazard?	N/A
N/A	Obstruction Type		N/A	Storm Grate/Utility Type	
			N/A		N/A
N/A	Surface Condition	Good

Possible Solutions:
Remove & Replace Entire Refuge.
