Access Compliance Report

Public Rights-of-Way

(Island Curb Cuts)

Intersection ID: 14455	Main Street: EAST_BV	Cross Street: WINTHROP_AV	Location: SE
ADA ID: C0D6C38A6D96	Curb Cut Type: MedianRefuge2	Initial Pass/Fail: Fail	Overall Compliance: No
Severity Score: 0			
Codes/Mitigation Info/Possible Solution		Field Measurements/Component Compliance

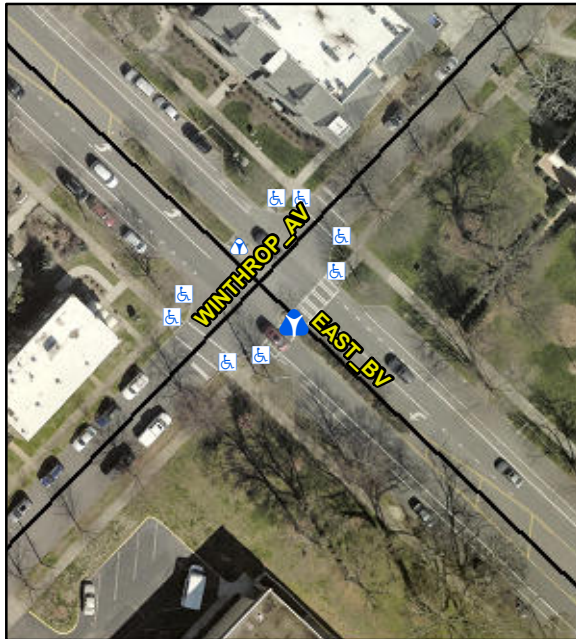
Compliance	Description	Data	Compliance	Description	Data
Yes	Refuge 1 Length (In)	37.5	N/A	Gutter 1 Ponding?	N/A
Yes	Refuge 1 Width (In)	87.0	N/A	Gutter 1 Lip Ht (In)	N/A
Yes	Refuge 1 Slope (%)	1.6	N/A	Gutter 1 Slope (%)	N/A
Yes	Refuge 1 X Slope (%)	3.0	N/A	Gutter 1 X Slope (%)	N/A
N/A	Painted X Walk1?	Yes	N/A	DWS 1 Provided?	N/A
N/A	X Walk 1 Direction	To SW	N/A	DWS 1 Contrast?	N/A
N/A	X Walk 1 Width (In)	110.0	N/A	DWS 1 Length (In)	N/A
N/A	Road 1 Slope (%)	2.3	N/A	DWS 1 Full Width?	N/A
N/A	Road 1 X Slope (%)	1.9	N/A	DWS 1 Offset (In)	N/A
Yes	Refuge 2 Length (In)	37.5	N/A	Gutter 2 Ponding?	N/A
Yes	Refuge 2 Width (In)	87.0	N/A	Gutter 2 Lip Ht (In)	N/A
Yes	Refuge 2 Slope (%)	1.2	N/A	Gutter 2 Slope (%)	N/A
Yes	Refuge 2 X Slope (%)	1.9	N/A	Gutter 2 X Slope (%)	N/A
N/A	Painted X Walk2?	Yes	N/A	DWS 2 Provided?	N/A
N/A	X Walk 2 Direction	To NE	N/A	DWS 2 Contrast?	N/A
N/A	X Walk 2 Width (In)	110.5	N/A	DWS 2 Length (In)	N/A

N/A	Road 2 Slope (%)	1.7	N/A	DWS 2 Full Width?	N/A
N/A	Road 2 X Slope (%)	0.5	N/A	DWS 2 Offset (In)	N/A
N/A	Refuge 3 Length (in)	N/A	N/A	Gutter 3 Ponding?	N/A
N/A	Refuge 3 Width (in)	N/A	N/A	Gutter 3 Lip Ht (in)	N/A
N/A	Refuge 3 Slope (%)	N/A	N/A	Gutter 3 Slope (%)	N/A
N/A	Refuge 3 XSlope (%)	N/A	N/A	Gutter 3 XSlope (%)	N/A
N/A	Painted X Walk3?	N/A	N/A	DWS 3 Provided?	N/A
N/A	X Walk 3 Direction	N/A	N/A	DWS 3 Contrast?	N/A
N/A	X Walk 3 Width (in)	N/A	N/A	DWS 3 Length (in)	N/A
N/A	Road 3 Slope (%)	N/A	N/A	DWS 3 Full Width?	N/A
N/A	Road 3 XSlope (%)	N/A	N/A	DWS 3 Offset (in)	N/A
Yes	Any Obstructions?	N/A	N/A	Storm Grate/Utility Hazard?	N/A
N/A	Obstruction Type		N/A	Storm Grate/Utility Type	
		N/A			N/A
N/A	Surface Condition	Good

Remove & Replace Entire Refuge.
