Access Compliance Report

Public Rights-of-Way

(Island Curb Cuts)

| Intersection ID: 5714 | Main Street: JOHN_KIRK_DR | Cross Street: UNIVERSITY_CITY_BV | Location: S |

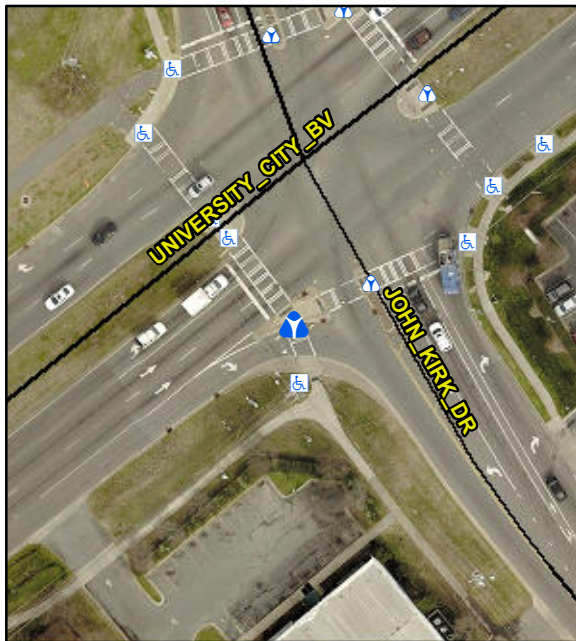
| ADA ID: C1B9F0C9CDF4 | Curb Cut Type: IslandRefuge3 | Initial Pass/Fail: Pass | Overall Compliance: No |
| Severity Score: 17.5 | | | |

| Compliance | Description | Data | Compliance | Description | Data |
|---|---|---|---|---|---|
| Yes | Refuge 1 Length (In) | 40.0 | No | Gutter 1 Ponding? | Yes |
| Yes | Refuge 1 Width (In) | 100.0 | No | Gutter 1 Lip Ht (In) | 0.5 |
| N/A | Road 1 Slope (%) | 1.8 | No | DWS 1 Full Width? | No |
| Yes | Refuge 2 Width (In) | 118.0 | No | Gutter 2 Lip Ht (In) | 0.5 |
| N/A | Road 2 Slope (%) | 1.1 | No | DWS 2 Full Width? | No |
| Yes | Refuge 3 Length (in) | 176.0 | No | Gutter 3 Ponding? | Yes |
| Yes | Refuge 3 Width (in) | 101.0 | No | Gutter 3 Lip Ht (in) | .25 |
| N/A | Road 3 Slope (%) | 0.1 | No | DWS 3 Full Width? | No |

Remove & Replace Detectable Warning System. Grind Gutter Lip.
