Access Compliance Report

Public Rights-of-Way

(Island Curb Cuts)

Intersection ID: 15477	Main Street: W_TYVOLA_RD	Cross Street: CASCADE_POINTE_BV	Location: W
ADA ID: C1C3BB116660	Curb Cut Type: IslandRefuge3	Initial Pass/Fail: Fail	Overall Compliance: No
Severity Score: 36.25			
Codes/Mitigation Info/Possible Solution		Field Measurements/Component Compliance

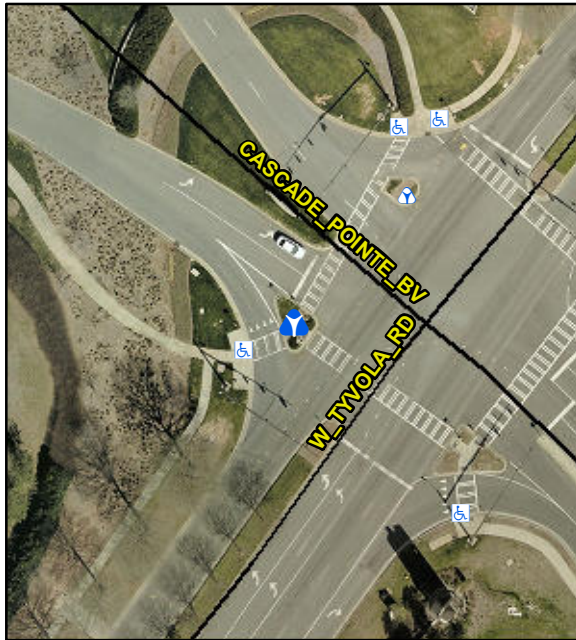
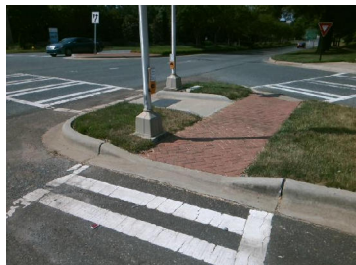
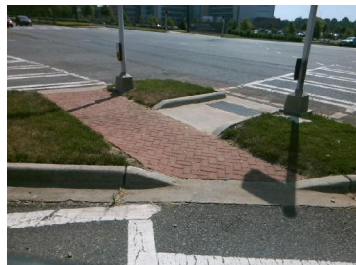
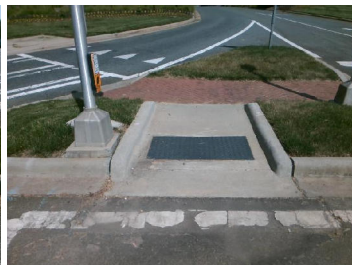
Compliance	Description	Data	Compliance	Description	Data
Yes	Refuge 1 Length (In)	92.0	N/A	Gutter 1 Ponding?	N/A
No	Refuge 1 Width (In)	59.0	N/A	Gutter 1 Lip Ht (In)	N/A
Yes	Refuge 1 Slope (%)	0.9	N/A	Gutter 1 Slope (%)	N/A
Yes	Refuge 1 X Slope (%)	4.1	N/A	Gutter 1 X Slope (%)	N/A
N/A	Painted X Walk1?	Yes	N/A	DWS 1 Provided?	N/A
N/A	X Walk 1 Direction	To NE	N/A	DWS 1 Contrast?	N/A
N/A	X Walk 1 Width (In)	83.0	N/A	DWS 1 Length (In)	N/A
N/A	Road 1 Slope (%)	3.0	N/A	DWS 1 Full Width?	N/A
N/A	Road 1 X Slope (%)	4.1	N/A	DWS 1 Offset (In)	N/A
Yes	Refuge 2 Length (In)	92.0	N/A	Gutter 2 Ponding?	N/A
No	Refuge 2 Width (In)	59.0	N/A	Gutter 2 Lip Ht (In)	N/A
Yes	Refuge 2 Slope (%)	2.3	N/A	Gutter 2 Slope (%)	N/A
Yes	Refuge 2 X Slope (%)	3.0	N/A	Gutter 2 X Slope (%)	N/A
N/A	Painted X Walk2?	Yes	N/A	DWS 2 Provided?	N/A
N/A	X Walk 2 Direction	To SW	N/A	DWS 2 Contrast?	N/A
N/A	X Walk 2 Width (In)	108.0	N/A	DWS 2 Length (In)	N/A

N/A	Road 2 Slope (%)	5.8	N/A	DWS 2 Full Width?	N/A
N/A	Road 2 X Slope (%)	1.2	N/A	DWS 2 Offset (In)	N/A
Yes	Refuge 3 Length (in)	83.0	N/A	Gutter 3 Ponding?	N/A
No	Refuge 3 Width (in)	58.0	N/A	Gutter 3 Lip Ht (in)	N/A
Yes	Refuge 3 Slope (%)	1.5	N/A	Gutter 3 Slope (%)	N/A
Yes	Refuge 3 XSlope (%)	1.4	N/A	Gutter 3 XSlope (%)	N/A
N/A	Painted X Walk3?	Yes	N/A	DWS 3 Provided?	N/A
N/A	X Walk 3 Direction	To SE	N/A	DWS 3 Contrast?	N/A
N/A	X Walk 3 Width (in)	112.0	N/A	DWS 3 Length (in)	N/A
N/A	Road 3 Slope (%)	2.5	N/A	DWS 3 Full Width?	N/A
N/A	Road 3 XSlope (%)	3.	N/A	DWS 3 Offset (in)	N/A
Yes	Any Obstructions?	N/A	N/A	Storm Grate/Utility Hazard?	N/A
N/A	Obstruction Type		N/A	Storm Grate/Utility Type	
N/A	Surface Condition	Good	N/A		N/A

Remove & Replace Entire Refuge.
