Access Compliance Report

Public Rights-of-Way

(Island Curb Cuts)

Intersection ID: 16248	Main Street: OAK_LAKE_BV	Cross Street: YORKMONT_RD	Location: E
ADA ID: C1FEFE201145	Curb Cut Type: MedianRefuge2	Initial Pass/Fail: Fail	Overall Compliance: No
Severity Score: 0			
Codes/Mitigation Info/Possible Solution		Field Measurements/Component Compliance

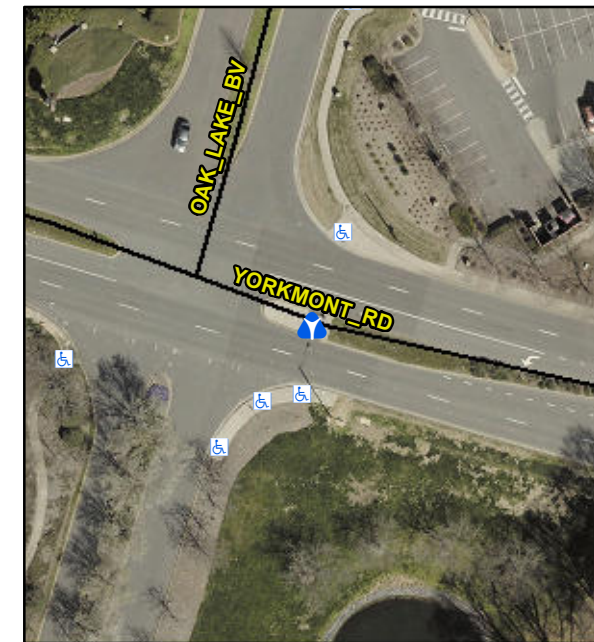
Compliance	Description	Data	Compliance	Description	Data
Yes	Refuge 1 Length (In)	79.0	N/A	Gutter 1 Ponding?	N/A
Yes	Refuge 1 Width (In)	100.0	N/A	Gutter 1 Lip Ht (In)	N/A
Yes	Refuge 1 Slope (%)	1.9	N/A	Gutter 1 Slope (%)	N/A
Yes	Refuge 1 X Slope (%)	2.9	N/A	Gutter 1 X Slope (%)	N/A
N/A	Painted X Walk1?	No	N/A	DWS 1 Provided?	N/A
N/A	X Walk 1 Direction	To S	N/A	DWS 1 Contrast?	N/A
N/A	X Walk 1 Width (In)	N/A	N/A	DWS 1 Length (In)	N/A
N/A	Road 1 Slope (%)	2.3	N/A	DWS 1 Full Width?	N/A
N/A	Road 1 X Slope (%)	0.5	N/A	DWS 1 Offset (In)	N/A
Yes	Refuge 2 Length (In)	79.0	N/A	Gutter 2 Ponding?	N/A
Yes	Refuge 2 Width (In)	100.0	N/A	Gutter 2 Lip Ht (In)	N/A
Yes	Refuge 2 Slope (%)	1.4	N/A	Gutter 2 Slope (%)	N/A
Yes	Refuge 2 X Slope (%)	4.3	N/A	Gutter 2 X Slope (%)	N/A
N/A	Painted X Walk2?	No	N/A	DWS 2 Provided?	N/A
N/A	X Walk 2 Direction	To N	N/A	DWS 2 Contrast?	N/A
N/A	X Walk 2 Width (In)	N/A	N/A	DWS 2 Length (In)	N/A

N/A	Road 2 Slope (%)	2.8	N/A	DWS 2 Full Width?	N/A
N/A	Road 2 X Slope (%)	4.7	N/A	DWS 2 Offset (In)	N/A
N/A	Refuge 3 Length (in)	N/A	N/A	Gutter 3 Ponding?	N/A
N/A	Refuge 3 Width (in)	N/A	N/A	Gutter 3 Lip Ht (in)	N/A
N/A	Refuge 3 Slope (%)	N/A	N/A	Gutter 3 Slope (%)	N/A
N/A	Refuge 3 XSlope (%)	N/A	N/A	Gutter 3 XSlope (%)	N/A
N/A	Painted X Walk3?	N/A	N/A	DWS 3 Provided?	N/A
N/A	X Walk 3 Direction	N/A	N/A	DWS 3 Contrast?	N/A
N/A	X Walk 3 Width (in)	N/A	N/A	DWS 3 Length (in)	N/A
N/A	Road 3 Slope (%)	N/A	N/A	DWS 3 Full Width?	N/A
N/A	Road 3 XSlope (%)	N/A	N/A	DWS 3 Offset (in)	N/A
Yes	Any Obstructions?	N/A	N/A	Storm Grate/Utility Hazard?	N/A
N/A	Obstruction Type		N/A	Storm Grate/Utility Type	
		N/A			N/A
N/A	Surface Condition	Good

Remove & Replace Entire Refuge.
