Access Compliance Report

Public Rights-of-Way

(Island Curb Cuts)

Intersection ID: 10031957	Main Street: MONROE_RD	Cross Street: N/A	Location: SW
ADA ID: C20030AC4C2C	Curb Cut Type: MedianRefuge2	Initial Pass/Fail: Fail	Overall Compliance: No
Codes/Mitigation Info/Possible Solution		Field Measurements/Component Compliance	
Severity Score: 0

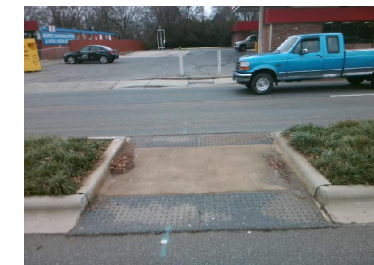
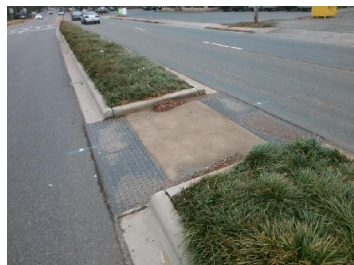
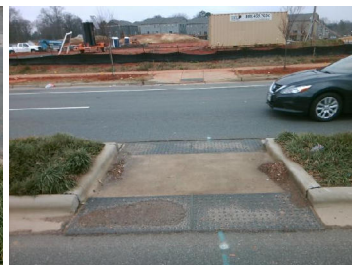
Compliance	Description	Data	Compliance	Description	Data
Yes	Refuge 1 Length (In)	40.0	N/A	Gutter 1 Ponding?	N/A
Yes	Refuge 1 Width (In)	96.0	N/A	Gutter 1 Lip Ht (In)	N/A
Yes	Refuge 1 Slope (%)	0.9	N/A	Gutter 1 Slope (%)	N/A
Yes	Refuge 1 X Slope (%)	2.2	N/A	Gutter 1 X Slope (%)	N/A
N/A	Painted X Walk1?	No	N/A	DWS 1 Provided?	N/A
N/A	X Walk 1 Direction	To SW	N/A	DWS 1 Contrast?	N/A
N/A	X Walk 1 Width (In)	N/A	N/A	DWS 1 Length (In)	N/A
N/A	Road 1 Slope (%)	1.9	N/A	DWS 1 Full Width?	N/A
N/A	Road 1 X Slope (%)	2.5	N/A	DWS 1 Offset (In)	N/A
Yes	Refuge 2 Length (In)	40.0	N/A	Gutter 2 Ponding?	N/A
Yes	Refuge 2 Width (In)	96.0	N/A	Gutter 2 Lip Ht (In)	N/A
Yes	Refuge 2 Slope (%)	1.5	N/A	Gutter 2 Slope (%)	N/A
Yes	Refuge 2 X Slope (%)	1.7	N/A	Gutter 2 X Slope (%)	N/A
N/A	Painted X Walk2?	No	N/A	DWS 2 Provided?	N/A
N/A	X Walk 2 Direction	To NE	N/A	DWS 2 Contrast?	N/A
N/A	X Walk 2 Width (In)	N/A	N/A	DWS 2 Length (In)	N/A

N/A	Road 2 Slope (%)	1.8	N/A	DWS 2 Full Width?	N/A
N/A	Road 2 X Slope (%)	3.5	N/A	DWS 2 Offset (In)	N/A
N/A	Refuge 3 Length (in)	N/A	N/A	Gutter 3 Ponding?	N/A
N/A	Refuge 3 Width (in)	N/A	N/A	Gutter 3 Lip Ht (in)	N/A
N/A	Refuge 3 Slope (%)	N/A	N/A	Gutter 3 Slope (%)	N/A
N/A	Refuge 3 XSlope (%)	N/A	N/A	Gutter 3 XSlope (%)	N/A
N/A	Painted X Walk3?	N/A	N/A	DWS 3 Provided?	N/A
N/A	X Walk 3 Direction	N/A	N/A	DWS 3 Contrast?	N/A
N/A	X Walk 3 Width (in)	N/A	N/A	DWS 3 Length (in)	N/A
N/A	Road 3 Slope (%)	N/A	N/A	DWS 3 Full Width?	N/A
N/A	Road 3 XSlope (%)	N/A	N/A	DWS 3 Offset (in)	N/A
Yes	Any Obstructions?	N/A	N/A	Storm Grate/Utility Hazard?	N/A
N/A	Obstruction Type		N/A	Storm Grate/Utility Type	
		N/A			N/A
N/A	Surface Condition	Good

Remove & Replace Entire Refuge.
