Access Compliance Report

Public Rights-of-Way

(Island Curb Cuts)

Intersection ID: 13713	Main Street: UNIVERSITY POINTE BV	Cross Street: IBM DR	Location: S
ADA ID: C4AA7EB228E1	Curb Cut Type: MedianRefuge2	Initial Pass/Fail: Fail	Overall Compliance: No
Severity Score: 1.25			
Codes/Mitigation Info/Possible Solution		Field Measurements/Component Compliance

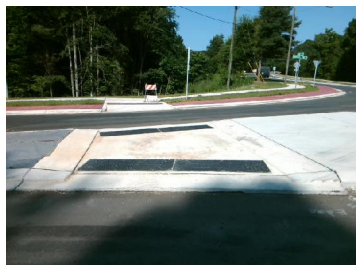
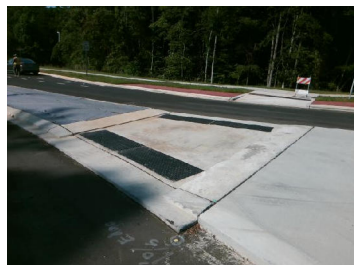
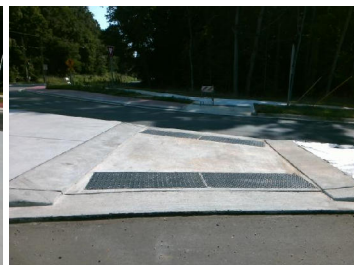
Compliance	Description	Data	Compliance	Description	Data
Yes	Refuge 1 Length (In)	62.0	N/A	Gutter 1 Ponding?	N/A
Yes	Refuge 1 Width (In)	124.5	N/A	Gutter 1 Lip Ht (In)	N/A
Yes	Refuge 1 Slope (%)	3.1	N/A	Gutter 1 Slope (%)	N/A
Yes	Refuge 1 X Slope (%)	4.9	N/A	Gutter 1 X Slope (%)	N/A
N/A	Painted X Walk1?	No	N/A	DWS 1 Provided?	N/A
N/A	X Walk 1 Direction	To E	N/A	DWS 1 Contrast?	N/A
N/A	X Walk 1 Width (In)	N/A	N/A	DWS 1 Length (In)	N/A
N/A	Road 1 Slope (%)	4.7	N/A	DWS 1 Full Width?	N/A
N/A	Road 1 X Slope (%)	2.1	N/A	DWS 1 Offset (In)	N/A
Yes	Refuge 2 Length (In)	62.0	N/A	Gutter 2 Ponding?	N/A
Yes	Refuge 2 Width (In)	124.5	N/A	Gutter 2 Lip Ht (In)	N/A
Yes	Refuge 2 Slope (%)	1.0	N/A	Gutter 2 Slope (%)	N/A
Yes	Refuge 2 X Slope (%)	4.8	N/A	Gutter 2 X Slope (%)	N/A
N/A	Painted X Walk2?	No	N/A	DWS 2 Provided?	N/A
N/A	X Walk 2 Direction	To W	N/A	DWS 2 Contrast?	N/A
N/A	X Walk 2 Width (In)	N/A	N/A	DWS 2 Length (In)	N/A

N/A	Road 2 Slope (%)	5.0	N/A	DWS 2 Full Width?	N/A
N/A	Road 2 X Slope (%)	4.7	N/A	DWS 2 Offset (In)	N/A
N/A	Refuge 3 Length (in)	N/A	N/A	Gutter 3 Ponding?	N/A
N/A	Refuge 3 Width (in)	N/A	N/A	Gutter 3 Lip Ht (in)	N/A
N/A	Refuge 3 Slope (%)	N/A	N/A	Gutter 3 Slope (%)	N/A
N/A	Refuge 3 XSlope (%)	N/A	N/A	Gutter 3 XSlope (%)	N/A
N/A	Painted X Walk3?	No	N/A	DWS 3 Provided?	N/A
N/A	X Walk 3 Direction	N/A	N/A	DWS 3 Contrast?	N/A
N/A	X Walk 3 Width (in)	N/A	N/A	DWS 3 Length (in)	N/A
N/A	Road 3 Slope (%)	N/A	N/A	DWS 3 Full Width?	N/A
N/A	Road 3 XSlope (%)	N/A	N/A	DWS 3 Offset (in)	N/A
Yes	Any Obstructions?	N/A	N/A	Storm Grate/Utility Hazard?	N/A
N/A	Obstruction Type		N/A	Storm Grate/Utility Type	
		N/A			N/A
N/A	Surface Condition	Good

Remove & Replace Entire Refuge.

\$ 3000.00
