Access Compliance Report

Public Rights-of-Way

(Island Curb Cuts)

Intersection ID: 28003	Main Street: COMMUNITY_HOUSE_RD	Cross Street: WILLOW_ROCK_DR	Location: E
ADA ID: C544AA72FB2E	Curb Cut Type: MedianRefuge2	Initial Pass/Fail: Fail	Overall Compliance: No
Codes/Mitigation Info/Possible Solution		Field Measurements/Component Compliance	
Severity Score: 0

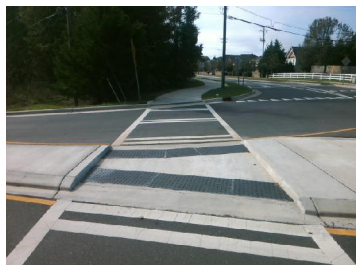
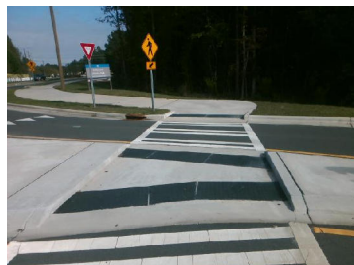
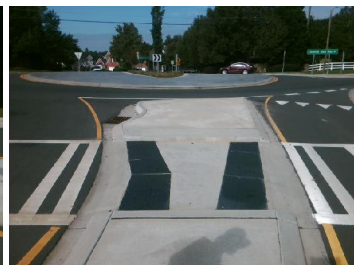
Compliance	Description	Data	Compliance	Description	Data
Yes	Refuge 1 Length (In)	36.5	N/A	Gutter 1 Ponding?	N/A
Yes	Refuge 1 Width (In)	118.0	N/A	Gutter 1 Lip Ht (In)	N/A
Yes	Refuge 1 Slope (%)	0.7	N/A	Gutter 1 Slope (%)	N/A
Yes	Refuge 1 X Slope (%)	2.2	N/A	Gutter 1 X Slope (%)	N/A
N/A	Painted X Walk1?	No	N/A	DWS 1 Provided?	N/A
N/A	X Walk 1 Direction	To SE	N/A	DWS 1 Contrast?	N/A
N/A	X Walk 1 Width (In)	110.0	N/A	DWS 1 Length (In)	N/A
N/A	Road 1 Slope (%)	1.0	N/A	DWS 1 Full Width?	N/A
N/A	Road 1 X Slope (%)	1.1	N/A	DWS 1 Offset (In)	N/A
Yes	Refuge 2 Length (In)	36.5	N/A	Gutter 2 Ponding?	N/A
Yes	Refuge 2 Width (In)	118.0	N/A	Gutter 2 Lip Ht (In)	N/A
Yes	Refuge 2 Slope (%)	1.6	N/A	Gutter 2 Slope (%)	N/A
Yes	Refuge 2 X Slope (%)	2.2	N/A	Gutter 2 X Slope (%)	N/A
N/A	Painted X Walk2?	Yes	N/A	DWS 2 Provided?	N/A
N/A	X Walk 2 Direction	To NW	N/A	DWS 2 Contrast?	N/A
N/A	X Walk 2 Width (In)	112.0	N/A	DWS 2 Length (In)	N/A

N/A	Road 2 Slope (%)	2.2	N/A	DWS 2 Full Width?	N/A
N/A	Road 2 X Slope (%)	3.3	N/A	DWS 2 Offset (In)	N/A
N/A	Refuge 3 Length (in)	N/A	N/A	Gutter 3 Ponding?	N/A
N/A	Refuge 3 Width (in)	N/A	N/A	Gutter 3 Lip Ht (in)	N/A
N/A	Refuge 3 Slope (%)	N/A	N/A	Gutter 3 Slope (%)	N/A
N/A	Refuge 3 XSlope (%)	N/A	N/A	Gutter 3 XSlope (%)	N/A
N/A	Painted X Walk3?	N/A	N/A	DWS 3 Provided?	N/A
N/A	X Walk 3 Direction	N/A	N/A	DWS 3 Contrast?	N/A
N/A	X Walk 3 Width (in)	N/A	N/A	DWS 3 Length (in)	N/A
N/A	Road 3 Slope (%)	N/A	N/A	DWS 3 Full Width?	N/A
N/A	Road 3 XSlope (%)	N/A	N/A	DWS 3 Offset (in)	N/A
Yes	Any Obstructions?	N/A	N/A	Storm Grate/Utility Hazard?	N/A
N/A	Obstruction Type		N/A	Storm Grate/Utility Type	
		N/A			N/A
N/A	Surface Condition	Good

Remove & Replace Entire Refuge.
