Access Compliance Report

Public Rights-of-Way

(Island Curb Cuts)

Intersection ID: 7770	Main Street: E_ARROWHEAD_DR	Cross Street: N_TRYON_ST	Location:	N
ADA ID: C713BB9F9E10	Curb Cut Type: MedianRefuge2	Initial Pass/Fail: Pass	Overall Compliance: No	Severity Score: 15.25

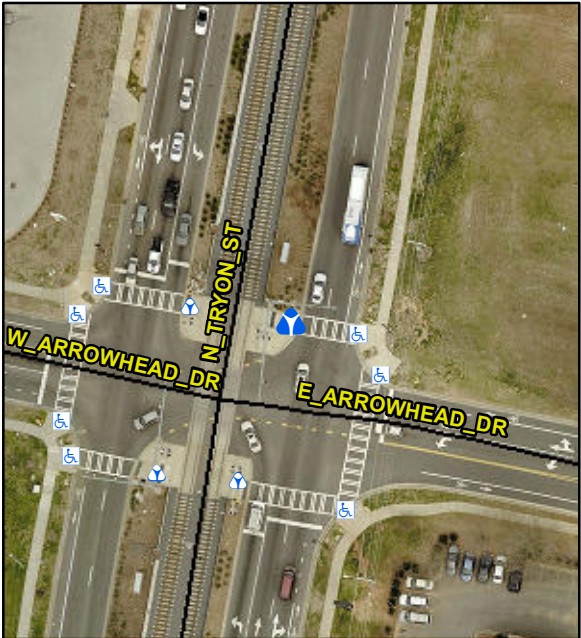
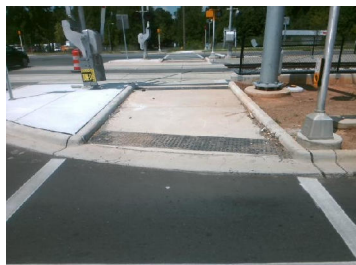
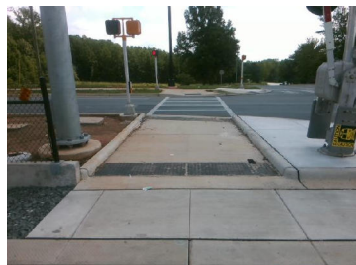
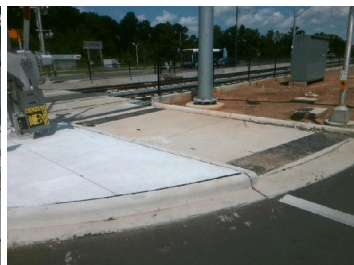
Possible Solutions:		Compliance	Description	Data	
	Remove & Replace Detectable Warning System. Grind Gutter Lip.		Yes	Refuge 1 Length (In)	92.5	No
			Yes	Refuge 1 Width (In)	120.0	No
			Yes	Refuge 1 Slope (%)	1.9	Yes
			Yes	Refuge 1 X Slope (%)	0.4	Yes
			N/A	Painted X Walk1?	Yes	Yes
			N/A	X Walk 1 Direction	To E	Yes
			N/A	X Walk 1 Width (In)	120.0	Yes
			N/A	Road 1 Slope (%)	0.0	Yes
			N/A	Road 1 X Slope (%)	2.5	No
<p>Surveyor Notes:</p> <p>N/A</p>			Yes	Refuge 2 Length (In)	109.0	Yes
			Yes	Refuge 2 Width (In)	120.0	Yes
			Yes	Refuge 2 Slope (%)	3.1	Yes
			Yes	Refuge 2 X Slope (%)	0.5	Yes
			N/A	Painted X Walk2?	No	Yes
			N/A	X Walk 2 Direction	To W	Yes
			N/A	X Walk 2 Width (In)	N/A	Yes
			N/A	Road 2 Slope (%)	0.5	Yes
			N/A	Road 2 X Slope (%)	0.2	Yes
			N/A	Refuge 3 Length (in)	N/A	N/A
<p>PROW/ADA:</p> <p>N/A</p>			N/A	Refuge 3 Width (in)	N/A	N/A
