Access Compliance Report

Public Rights-of-Way

(Island Curb Cuts)

Intersection ID: 51702	Main Street: PROSPERITY_RIDGE_RD	Cross Street: N/A	Location: N
ADA ID: C797282F0CE7	Curb Cut Type: MedianRefuge2	Initial Pass/Fail: Pass	Overall Compliance: No
			Severity Score: 15

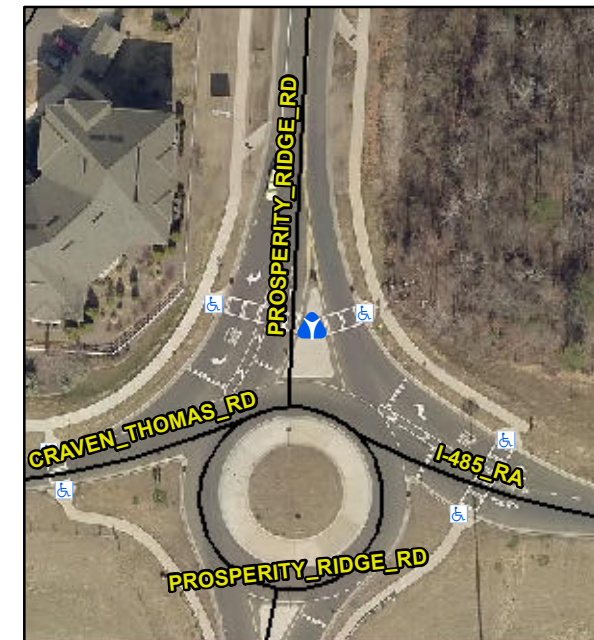
Compliance	Description	Data	Compliance	Description	Data
Yes	Refuge 1 Length (In)	54.0	Yes	Gutter 1 Ponding?	No
Yes	Refuge 1 Width (In)	118.0	Yes	Gutter 1 Lip Ht (In)	0.0
Yes	Refuge 1 Slope (%)	0.7	Yes	Gutter 1 Slope (%)	0.9
Yes	Refuge 1 X Slope (%)	1.8	Yes	Gutter 1 X Slope (%)	.19
N/A	Painted X Walk1?	Yes	No	DWS 1 Provided?	No
N/A	X Walk 1 Direction	To W	N/A	DWS 1 Contrast?	No
N/A	X Walk 1 Width (In)	103.0	N/A	DWS 1 Length (In)	N/A
N/A	Road 1 Slope (%)	2.3	N/A	DWS 1 Full Width?	No
N/A	Road 1 X Slope (%)	1.0	N/A	DWS 1 Offset (In)	N/A
Yes	Refuge 2 Length (In)	54.0	Yes	Gutter 2 Ponding?	No
Yes	Refuge 2 Width (In)	118.0	Yes	Gutter 2 Lip Ht (In)	0.0
Yes	Refuge 2 Slope (%)	0.2	Yes	Gutter 2 Slope (%)	1.5
Yes	Refuge 2 X Slope (%)	1.4	Yes	Gutter 2 X Slope (%)	1.1
N/A	Painted X Walk2?	Yes	No	DWS 2 Provided?	No
N/A	X Walk 2 Direction	To E	N/A	DWS 2 Contrast?	No
N/A	X Walk 2 Width (In)	103.0	N/A	DWS 2 Length (In)	N/A

Install Detectable Warning System.
