# Access Compliance Report

## Public Rights-of-Way

### (Island Curb Cuts)

Intersection ID: 26246	Main Street: PROVIDENCE_RD	Cross Street: RAINTREE_LN	Location:	W
ADA ID: C8823095DB93	Curb Cut Type: MedianRefuge2	Initial Pass/Fail: Fail	Overall Compliance: No	Severity Score: 10
Codes/Mitigation Info/Possible Solution		Field Measurements/Component Compliance

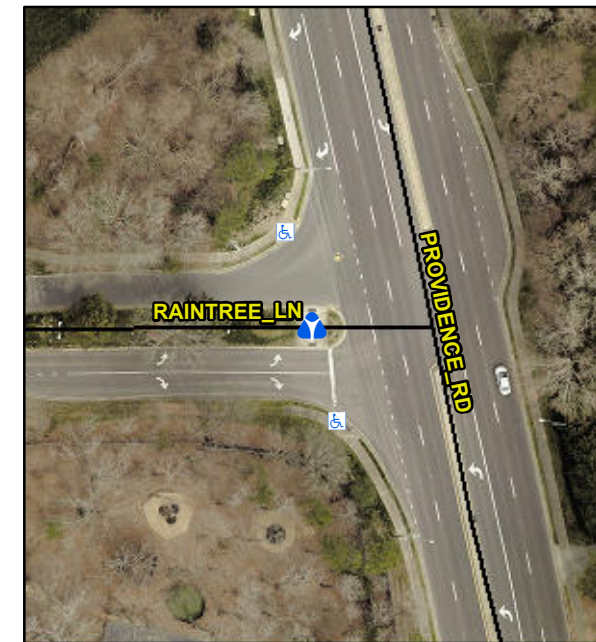
Compliance	Description	Data	Compliance	Description	Data
Yes	Refuge 1 Length (In)	118.5	N/A	Gutter 1 Ponding?	N/A
No	Refuge 1 Width (In)	50.0	N/A	Gutter 1 Lip Ht (In)	N/A
Yes	Refuge 1 Slope (%)	4.6	N/A	Gutter 1 Slope (%)	N/A
Yes	Refuge 1 X Slope (%)	4.6	N/A	Gutter 1 X Slope (%)	N/A
N/A	Painted X Walk1?	No	N/A	DWS 1 Provided?	N/A
N/A	X Walk 1 Direction	To N	N/A	DWS 1 Contrast?	N/A
N/A	X Walk 1 Width (In)	N/A	N/A	DWS 1 Length (In)	N/A
N/A	Road 1 Slope (%)	4.8	N/A	DWS 1 Full Width?	N/A
N/A	Road 1 X Slope (%)	0.9	N/A	DWS 1 Offset (In)	N/A
Yes	Refuge 2 Length (In)	118.5	N/A	Gutter 2 Ponding?	N/A
No	Refuge 2 Width (In)	50.0	N/A	Gutter 2 Lip Ht (In)	N/A
Yes	Refuge 2 Slope (%)	2.0	N/A	Gutter 2 Slope (%)	N/A
Yes	Refuge 2 X Slope (%)	4.0	N/A	Gutter 2 X Slope (%)	N/A
N/A	Painted X Walk2?	No	N/A	DWS 2 Provided?	N/A
N/A	X Walk 2 Direction	To S	N/A	DWS 2 Contrast?	N/A
N/A	X Walk 2 Width (In)	N/A	N/A	DWS 2 Length (In)	N/A

**Remove & Replace Entire Refuge.**
