Access Compliance Report

Public Rights-of-Way

(Island Curb Cuts)

Intersection ID: 47099	Main Street: GALLERIA_BV	Cross Street: N/A	Location: NE
ADA ID: C953EF18C98D	Curb Cut Type: MedianRefuge2	Initial Pass/Fail: Pass	Overall Compliance: No
Codes/Mitigation Info/Possible Solution		Field Measurements/Component Compliance

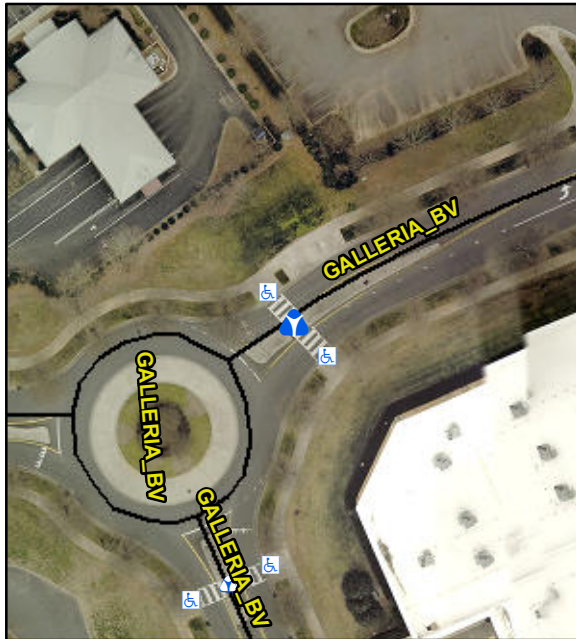
Compliance	Description	Data	Compliance	Description	Data
Yes	Refuge 1 Length (In)	41.5	Yes	Gutter 1 Ponding?	No
Yes	Refuge 1 Width (In)	120.0	Yes	Gutter 1 Lip Ht (In)	0.0
Yes	Refuge 1 Slope (%)	3.0	Yes	Gutter 1 Slope (%)	2.0
Yes	Refuge 1 X Slope (%)	0.1	Yes	Gutter 1 X Slope (%)	1.1
N/A	Painted X Walk1?	Yes	No	DWS 1 Provided?	No
N/A	X Walk 1 Direction	To SE	N/A	DWS 1 Contrast?	No
N/A	X Walk 1 Width (In)	111.0	N/A	DWS 1 Length (In)	N/A
N/A	Road 1 Slope (%)	0.9	N/A	DWS 1 Full Width?	No
N/A	Road 1 X Slope (%)	1.4	N/A	DWS 1 Offset (In)	N/A
Yes	Refuge 2 Length (In)	41.5	Yes	Gutter 2 Ponding?	No
Yes	Refuge 2 Width (In)	120.0	Yes	Gutter 2 Lip Ht (In)	0.0
Yes	Refuge 2 Slope (%)	2.3	Yes	Gutter 2 Slope (%)	2.2
Yes	Refuge 2 X Slope (%)	0.2	Yes	Gutter 2 X Slope (%)	0.4
N/A	Painted X Walk2?	Yes	No	DWS 2 Provided?	No
N/A	X Walk 2 Direction	To NW	N/A	DWS 2 Contrast?	No
N/A	X Walk 2 Width (In)	109.0	N/A	DWS 2 Length (In)	N/A

Install Detectable Warning System.
