Access Compliance Report

Public Rights-of-Way

(Island Curb Cuts)

Intersection ID: 17739	Main Street: E_WOODLAWN_RD	Cross Street: SOUTH_BV	Location: N
ADA ID: C9BED6A5BC97	Curb Cut Type: MedianRefuge2	Initial Pass/Fail: Fail	Overall Compliance: No
Codes/Mitigation Info/Possible Solution		Field Measurements/Component Compliance

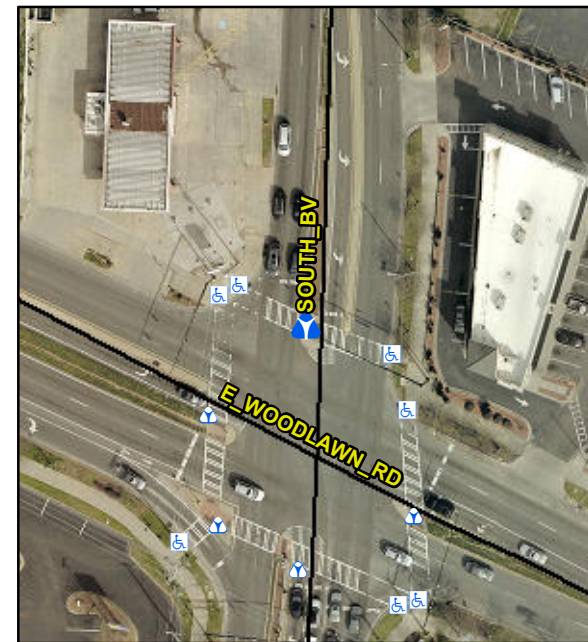
Compliance	Description	Data	Compliance	Description	Data
Yes	Refuge 1 Length (In)	68.5	N/A	Gutter 1 Ponding?	N/A
Yes	Refuge 1 Width (In)	119.0	N/A	Gutter 1 Lip Ht (In)	N/A
Yes	Refuge 1 Slope (%)	0.9	N/A	Gutter 1 Slope (%)	N/A
Yes	Refuge 1 X Slope (%)	2.9	N/A	Gutter 1 X Slope (%)	N/A
N/A	Painted X Walk1?	Yes	N/A	DWS 1 Provided?	N/A
N/A	X Walk 1 Direction	To E	N/A	DWS 1 Contrast?	N/A
N/A	X Walk 1 Width (In)	116.0	N/A	DWS 1 Length (In)	N/A
N/A	Road 1 Slope (%)	0.6	N/A	DWS 1 Full Width?	N/A
N/A	Road 1 X Slope (%)	2.9	N/A	DWS 1 Offset (In)	N/A
Yes	Refuge 2 Length (In)	68.5	N/A	Gutter 2 Ponding?	N/A
Yes	Refuge 2 Width (In)	119.0	N/A	Gutter 2 Lip Ht (In)	N/A
Yes	Refuge 2 Slope (%)	1.3	N/A	Gutter 2 Slope (%)	N/A
Yes	Refuge 2 X Slope (%)	0.9	N/A	Gutter 2 X Slope (%)	N/A
N/A	Painted X Walk2?	Yes	N/A	DWS 2 Provided?	N/A
N/A	X Walk 2 Direction	To W	N/A	DWS 2 Contrast?	N/A
N/A	X Walk 2 Width (In)	117.0	N/A	DWS 2 Length (In)	N/A

N/A	Road 2 Slope (%)	0.4	N/A	DWS 2 Full Width?	N/A
N/A	Road 2 X Slope (%)	3.2	N/A	DWS 2 Offset (In)	N/A
N/A	Refuge 3 Length (in)	N/A	N/A	Gutter 3 Ponding?	N/A
N/A	Refuge 3 Width (in)	N/A	N/A	Gutter 3 Lip Ht (in)	N/A
N/A	Refuge 3 Slope (%)	N/A	N/A	Gutter 3 Slope (%)	N/A
N/A	Refuge 3 XSlope (%)	N/A	N/A	Gutter 3 XSlope (%)	N/A
N/A	Painted X Walk3?	N/A	N/A	DWS 3 Provided?	N/A
N/A	X Walk 3 Direction	N/A	N/A	DWS 3 Contrast?	N/A
N/A	X Walk 3 Width (in)	N/A	N/A	DWS 3 Length (in)	N/A
N/A	Road 3 Slope (%)	N/A	N/A	DWS 3 Full Width?	N/A
N/A	Road 3 XSlope (%)	N/A	N/A	DWS 3 Offset (in)	N/A
Yes	Any Obstructions?	N/A	N/A	Storm Grate/Utility Hazard?	N/A
N/A	Obstruction Type		N/A	Storm Grate/Utility Type	
		N/A			N/A
N/A	Surface Condition	Good

Remove & Replace Entire Refuge.
