Access Compliance Report

Public Rights-of-Way

(Island Curb Cuts)

Intersection ID: 23437	Main Street: MOSS_RD	Cross Street: S_TRYON_ST	Location: S
ADA ID: C9DFD3388B97	Curb Cut Type: MedianRefuge2	Initial Pass/Fail: Pass	Overall Compliance: No
Severity Score: 25			
Codes/Mitigation Info/Possible Solution		Field Measurements/Component Compliance

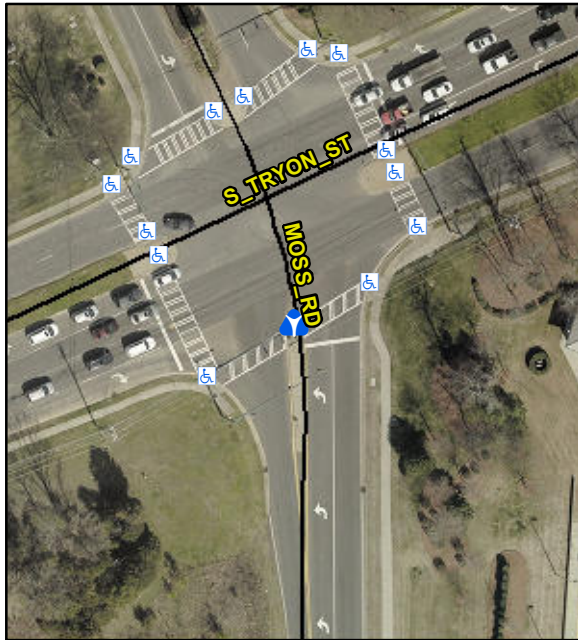
Compliance	Description	Data	Compliance	Description	Data
Yes	Refuge 1 Length (In)	50.0	No	Gutter 1 Ponding?	Yes
Yes	Refuge 1 Width (In)	96.0	Yes	Gutter 1 Lip Ht (In)	0.0
Yes	Refuge 1 Slope (%)	0.4	Yes	Gutter 1 Slope (%)	0.0
Yes	Refuge 1 X Slope (%)	0.5	Yes	Gutter 1 X Slope (%)	0.6
N/A	Painted X Walk1?	Yes	No	DWS 1 Provided?	No
N/A	X Walk 1 Direction	To NE	N/A	DWS 1 Contrast?	N/A
N/A	X Walk 1 Width (In)	118.0	N/A	DWS 1 Length (In)	N/A
N/A	Road 1 Slope (%)	0.5	N/A	DWS 1 Full Width?	N/A
N/A	Road 1 X Slope (%)	1.2	N/A	DWS 1 Offset (In)	N/A
Yes	Refuge 2 Length (In)	50.0	No	Gutter 2 Ponding?	Yes
Yes	Refuge 2 Width (In)	96.0	No	Gutter 2 Lip Ht (In)	0.25
Yes	Refuge 2 Slope (%)	0.4	No	Gutter 2 Slope (%)	6.7
Yes	Refuge 2 X Slope (%)	1.0	Yes	Gutter 2 X Slope (%)	0.9
N/A	Painted X Walk2?	Yes	No	DWS 2 Provided?	No
N/A	X Walk 2 Direction	To SW	N/A	DWS 2 Contrast?	N/A
N/A	X Walk 2 Width (In)	130.0	N/A	DWS 2 Length (In)	N/A

Possible Solutions:

**Install Detectable Warning System.
Fix Gutter Ponding. Remove &
Replace Gutter.**

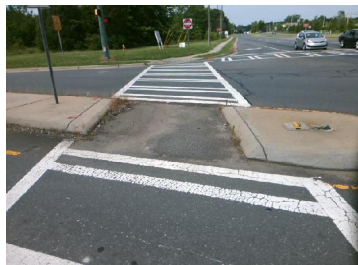
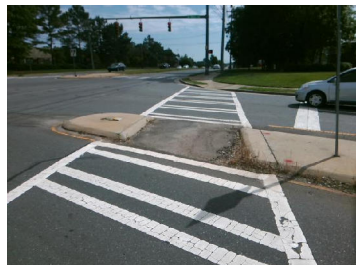
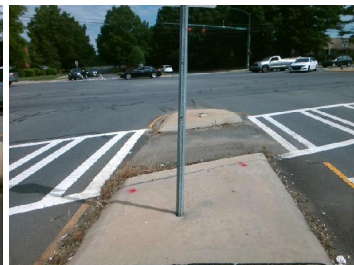
N/A	Road 2 Slope (%)	1.0	N/A	DWS 2 Full Width?	N/A
N/A	Road 2 X Slope (%)	1.6	N/A	DWS 2 Offset (In)	N/A
N/A	Refuge 3 Length (in)	N/A	N/A	Gutter 3 Ponding?	N/A
N/A	Refuge 3 Width (in)	N/A	N/A	Gutter 3 Lip Ht (in)	N/A
N/A	Refuge 3 Slope (%)	N/A	N/A	Gutter 3 Slope (%)	N/A
N/A	Refuge 3 XSlope (%)	N/A	N/A	Gutter 3 XSlope (%)	N/A
N/A	Painted X Walk3?	N/A	N/A	DWS 3 Provided?	N/A
N/A	X Walk 3 Direction	N/A	N/A	DWS 3 Contrast?	N/A
N/A	X Walk 3 Width (in)	N/A	N/A	DWS 3 Length (in)	N/A
N/A	Road 3 Slope (%)	N/A	N/A	DWS 3 Full Width?	N/A
N/A	Road 3 XSlope (%)	N/A	N/A	DWS 3 Offset (in)	N/A
Yes	Any Obstructions?	N/A	N/A	Storm Grate/Utility Hazard?	No
N/A	Obstruction Type		N/A	Storm Grate/Utility Type	
		N/A			N/A
N/A	Surface Condition	Good
