Access Compliance Report

Public Rights-of-Way

(Island Curb Cuts)

Intersection ID: 11423	Main Street: S_SUMMIT_AV	Cross Street: W_4TH_ST_EXT	Location: W
ADA ID: CB796AA49FD9	Curb Cut Type: MedianRefuge2	Initial Pass/Fail: Fail	Overall Compliance: No
Severity Score: 0			
Codes/Mitigation Info/Possible Solution		Field Measurements/Component Compliance

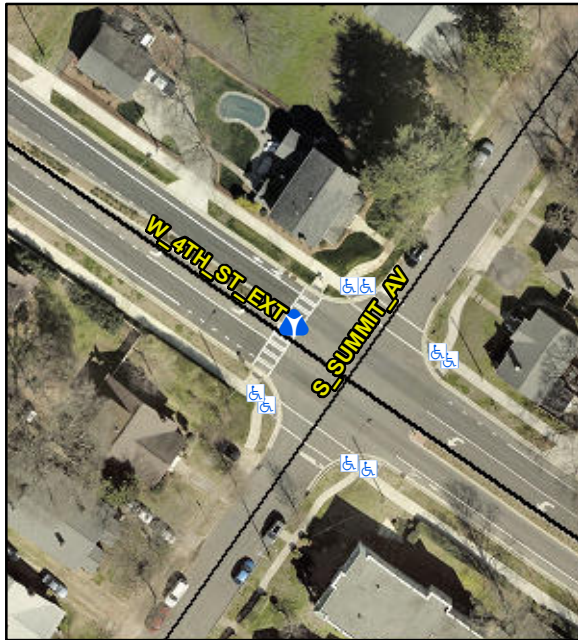
Compliance	Description	Data	Compliance	Description	Data
No	Refuge 1 Length (In)	30.0	N/A	Gutter 1 Ponding?	N/A
Yes	Refuge 1 Width (In)	83.5	N/A	Gutter 1 Lip Ht (In)	N/A
Yes	Refuge 1 Slope (%)	1.4	N/A	Gutter 1 Slope (%)	N/A
Yes	Refuge 1 X Slope (%)	1.9	N/A	Gutter 1 X Slope (%)	N/A
N/A	Painted X Walk1?	No	N/A	DWS 1 Provided?	N/A
N/A	X Walk 1 Direction	To NE	N/A	DWS 1 Contrast?	N/A
N/A	X Walk 1 Width (In)	N/A	N/A	DWS 1 Length (In)	N/A
N/A	Road 1 Slope (%)	2.7	N/A	DWS 1 Full Width?	N/A
N/A	Road 1 X Slope (%)	1.1	N/A	DWS 1 Offset (In)	N/A
No	Refuge 2 Length (In)	30.0	N/A	Gutter 2 Ponding?	N/A
Yes	Refuge 2 Width (In)	83.5	N/A	Gutter 2 Lip Ht (In)	N/A
Yes	Refuge 2 Slope (%)	1.9	N/A	Gutter 2 Slope (%)	N/A
Yes	Refuge 2 X Slope (%)	3.5	N/A	Gutter 2 X Slope (%)	N/A
N/A	Painted X Walk2?	No	N/A	DWS 2 Provided?	N/A
N/A	X Walk 2 Direction	To SW	N/A	DWS 2 Contrast?	N/A
N/A	X Walk 2 Width (In)	N/A	N/A	DWS 2 Length (In)	N/A

Remove & Replace Entire Refuge.
