# Access Compliance Report

## Public Rights-of-Way

### (Island Curb Cuts)

Intersection ID: 14466	Main Street: W_TYVOLA_RD	Cross Street: RICHARD_ST	Location: S
ADA ID: CB97CA72287A	Curb Cut Type: MedianRefuge2	Initial Pass/Fail: Fail	Overall Compliance: No
Codes/Mitigation Info/Possible Solution		Field Measurements/Component Compliance

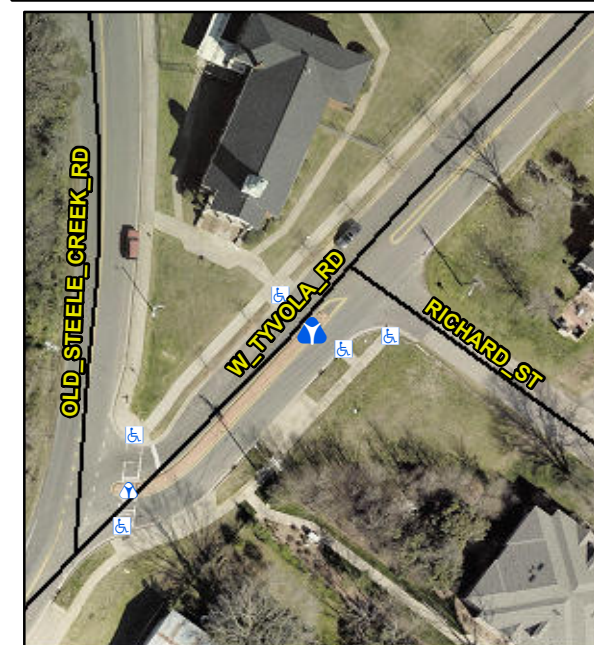
Compliance	Description	Data	Compliance	Description	Data
Yes	Refuge 1 Length (In)	36.0	N/A	Gutter 1 Ponding?	N/A
Yes	Refuge 1 Width (In)	96.0	N/A	Gutter 1 Lip Ht (In)	N/A
Yes	Refuge 1 Slope (%)	0.2	N/A	Gutter 1 Slope (%)	N/A
Yes	Refuge 1 X Slope (%)	3.0	N/A	Gutter 1 X Slope (%)	N/A
N/A	Painted X Walk1?	No	N/A	DWS 1 Provided?	N/A
N/A	X Walk 1 Direction	To W	N/A	DWS 1 Contrast?	N/A
N/A	X Walk 1 Width (In)	N/A	N/A	DWS 1 Length (In)	N/A
N/A	Road 1 Slope (%)	3.0	N/A	DWS 1 Full Width?	N/A
N/A	Road 1 X Slope (%)	3.1	N/A	DWS 1 Offset (In)	N/A
Yes	Refuge 2 Length (In)	36.0	N/A	Gutter 2 Ponding?	N/A
Yes	Refuge 2 Width (In)	96.0	N/A	Gutter 2 Lip Ht (In)	N/A
Yes	Refuge 2 Slope (%)	0.9	N/A	Gutter 2 Slope (%)	N/A
Yes	Refuge 2 X Slope (%)	3.6	N/A	Gutter 2 X Slope (%)	N/A
N/A	Painted X Walk2?	No	N/A	DWS 2 Provided?	N/A
N/A	X Walk 2 Direction	To E	N/A	DWS 2 Contrast?	N/A
N/A	X Walk 2 Width (In)	N/A	N/A	DWS 2 Length (In)	N/A

N/A	Road 2 Slope (%)	2.8	N/A	DWS 2 Full Width?	N/A
N/A	Road 2 X Slope (%)	3.6	N/A	DWS 2 Offset (In)	N/A
N/A	Refuge 3 Length (in)	N/A	N/A	Gutter 3 Ponding?	N/A
N/A	Refuge 3 Width (in)	N/A	N/A	Gutter 3 Lip Ht (in)	N/A
N/A	Refuge 3 Slope (%)	N/A	N/A	Gutter 3 Slope (%)	N/A
N/A	Refuge 3 XSlope (%)	N/A	N/A	Gutter 3 XSlope (%)	N/A
N/A	Painted X Walk3?	N/A	N/A	DWS 3 Provided?	N/A
N/A	X Walk 3 Direction	N/A	N/A	DWS 3 Contrast?	N/A
N/A	X Walk 3 Width (in)	N/A	N/A	DWS 3 Length (in)	N/A
N/A	Road 3 Slope (%)	N/A	N/A	DWS 3 Full Width?	N/A
N/A	Road 3 XSlope (%)	N/A	N/A	DWS 3 Offset (in)	N/A
Yes	Any Obstructions?	N/A	N/A	Storm Grate/Utility Hazard?	N/A
N/A	Obstruction Type		N/A	Storm Grate/Utility Type	
		N/A			N/A
N/A	Surface Condition	Good

Possible Solutions:

**Remove & Replace Entire Refuge.**

Total Cost: \$ 3000.00
