# Access Compliance Report

## Public Rights-of-Way

### (Island Curb Cuts)

Intersection ID: 10025963	Main Street: ELM_LN	Cross Street: N/A	Location: N
ADA ID: CBA39A754C95	Curb Cut Type: MedianRefuge2	Initial Pass/Fail: Pass	Overall Compliance: No
Severity Score: 0.25			
Codes/Mitigation Info/Possible Solution		Field Measurements/Component Compliance

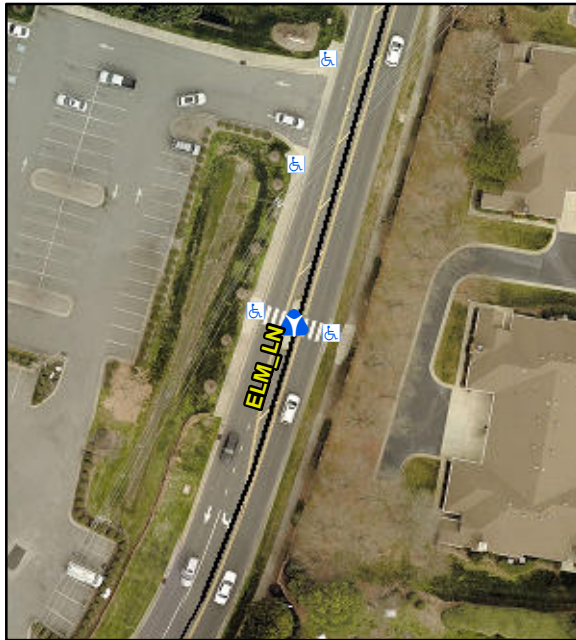
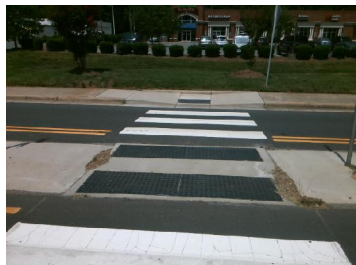
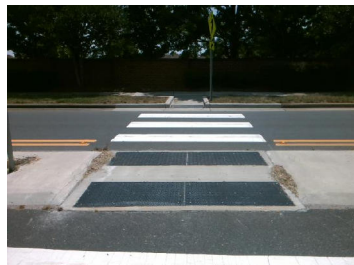
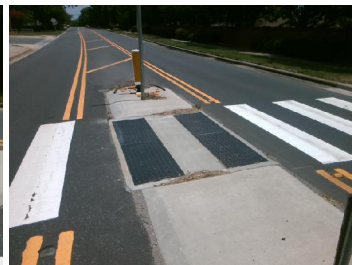
Compliance	Description	Data	Compliance	Description	Data
No	Refuge 1 Length (In)	33.5	Yes	Gutter 1 Ponding?	No
Yes	Refuge 1 Width (In)	108.0	Yes	Gutter 1 Lip Ht (In)	0.0
Yes	Refuge 1 Slope (%)	3.4	Yes	Gutter 1 Slope (%)	2.4
Yes	Refuge 1 X Slope (%)	0.7	Yes	Gutter 1 X Slope (%)	0.2
N/A	Painted X Walk1?	Yes	No	DWS 1 Provided?	Yes
N/A	X Walk 1 Direction	To NW	N/A	DWS 1 Contrast?	Yes
N/A	X Walk 1 Width (In)	122.0	N/A	DWS 1 Length (In)	24.0
N/A	Road 1 Slope (%)	0.4	N/A	DWS 1 Full Width?	Yes
N/A	Road 1 X Slope (%)	6.4	N/A	DWS 1 Offset (In)	3.0
No	Refuge 2 Length (In)	33.5	Yes	Gutter 2 Ponding?	No
Yes	Refuge 2 Width (In)	108.0	Yes	Gutter 2 Lip Ht (In)	0.0
Yes	Refuge 2 Slope (%)	2.8	Yes	Gutter 2 Slope (%)	3.8
Yes	Refuge 2 X Slope (%)	0.6	Yes	Gutter 2 X Slope (%)	0.1
N/A	Painted X Walk2?	No	No	DWS 2 Provided?	Yes
N/A	X Walk 2 Direction	To SE	N/A	DWS 2 Contrast?	Yes
N/A	X Walk 2 Width (In)	N/A	N/A	DWS 2 Length (In)	24.0

**Remove & Replace Entire Refuge.**
