Access Compliance Report

Public Rights-of-Way

(Island Curb Cuts)

Intersection ID: 12937	Main Street: E_W_T_HARRIS_BV	Cross Street: HICKORY_GROVE_RD	Location: SW
ADA ID: CBE22B3FC9D2	Curb Cut Type: MedianRefuge2	Initial Pass/Fail: Pass	Overall Compliance: Yes
Codes/Mitigation Info/Possible Solution		Field Measurements/Component Compliance	
Severity Score: 0

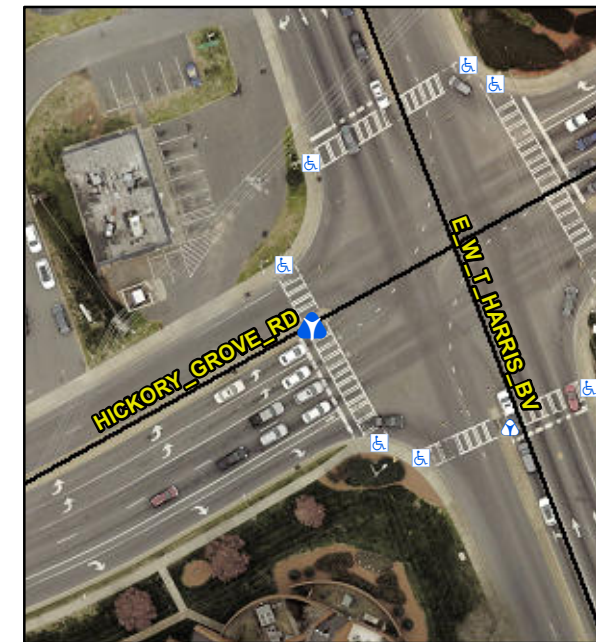
Compliance	Description	Data	Compliance	Description	Data
Yes	Refuge 1 Length (In)	36.0	Yes	Gutter 1 Ponding?	N/A
Yes	Refuge 1 Width (In)	96.0	Yes	Gutter 1 Lip Ht (In)	0.0
Yes	Refuge 1 Slope (%)	0.6	Yes	Gutter 1 Slope (%)	3.1
Yes	Refuge 1 X Slope (%)	0.8	Yes	Gutter 1 X Slope (%)	0.7
N/A	Painted X Walk1?	Yes	Yes	DWS 1 Provided?	Yes
N/A	X Walk 1 Direction	To N	Yes	DWS 1 Contrast?	Yes
N/A	X Walk 1 Width (In)	122.0	Yes	DWS 1 Length (In)	24.0
N/A	Road 1 Slope (%)	0.7	Yes	DWS 1 Full Width?	Yes
N/A	Road 1 X Slope (%)	1.4	Yes	DWS 1 Offset (In)	0.0
Yes	Refuge 2 Length (In)	36.0	Yes	Gutter 2 Ponding?	No
Yes	Refuge 2 Width (In)	96.0	Yes	Gutter 2 Lip Ht (In)	0.0
Yes	Refuge 2 Slope (%)	0.4	Yes	Gutter 2 Slope (%)	0.8
Yes	Refuge 2 X Slope (%)	0.3	Yes	Gutter 2 X Slope (%)	0.1
N/A	Painted X Walk2?	Yes	Yes	DWS 2 Provided?	Yes
N/A	X Walk 2 Direction	To N	Yes	DWS 2 Contrast?	Yes
N/A	X Walk 2 Width (In)	123.0	Yes	DWS 2 Length (In)	24.0

N/A	Road 2 Slope (%)	0.	Yes	DWS 2 Full Width?	Yes
N/A	Road 2 X Slope (%)	1.1	Yes	DWS 2 Offset (In)	0.0
N/A	Refuge 3 Length (in)	N/A	N/A	Gutter 3 Ponding?	No
N/A	Refuge 3 Width (in)	N/A	N/A	Gutter 3 Lip Ht (in)	N/A
N/A	Refuge 3 Slope (%)	N/A	N/A	Gutter 3 Slope (%)	N/A
N/A	Refuge 3 XSlope (%)	N/A	N/A	Gutter 3 XSlope (%)	N/A
N/A	Painted X Walk3?	No	N/A	DWS 3 Provided?	N/A
N/A	X Walk 3 Direction	N/A	N/A	DWS 3 Contrast?	N/A
N/A	X Walk 3 Width (in)	N/A	N/A	DWS 3 Length (in)	N/A
N/A	Road 3 Slope (%)	N/A	N/A	DWS 3 Full Width?	N/A
N/A	Road 3 XSlope (%)	N/A	N/A	DWS 3 Offset (in)	N/A
Yes	Any Obstructions?	No	N/A	Storm Grate/Utility Hazard?	No
N/A	Obstruction Type		N/A	Storm Grate/Utility Type	
		N/A			N/A
N/A	Surface Condition	Good
