Access Compliance Report

Public Rights-of-Way

(Island Curb Cuts)

| Intersection ID: 8157 | Main Street: N_TRYON_ST | Cross Street: ORR_RD | Location: S |

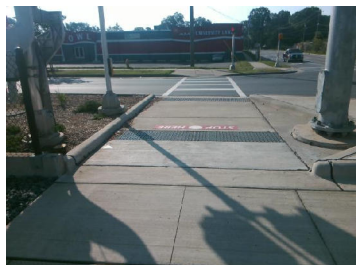
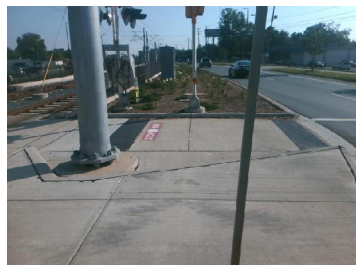
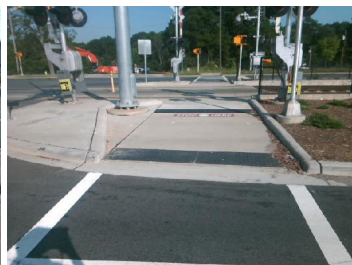
| Compliance | Description | Data | Compliance | Description | Data |
|---|---|---|---|---|---|
| N/A | Road 1 X Slope (%) | 2.9 | No | DWS 1 Offset (In) | 42.0 |
| N/A | Road 2 X Slope (%) | 2.7 | No | DWS 2 Offset (In) | 3.0 |

Remove & Replace Detectable Warning System.
