Access Compliance Report

Public Rights-of-Way

(Island Curb Cuts)

| Intersection ID: 22317 | Main Street: SHARON_RD | Cross Street: SHARON_ACRES_RD | Location: W |

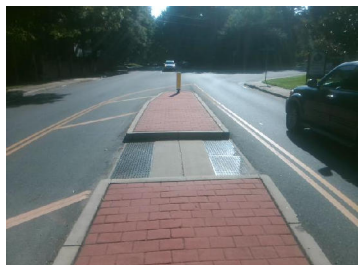
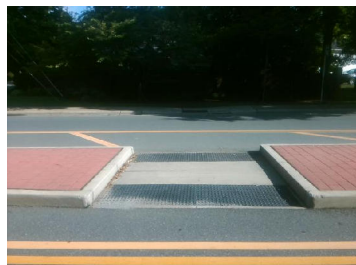
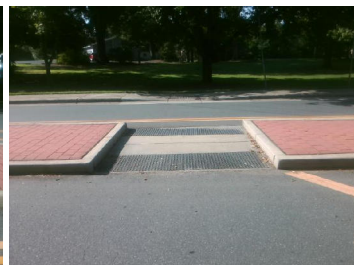
| ADA ID: CE80BAE28590 | Curb Cut Type: MedianRefuge2 | Initial Pass/Fail: Fail | Overall Compliance: No |
| Severity Score: 1.25 | | | |

Possible Solutions:

Remove & Replace Entire Refuge.
