Access Compliance Report

Public Rights-of-Way

(Island Curb Cuts)

Intersection ID: 12448	Main Street: HOLTON_AV	Cross Street: WILKINSON_BV	Location: E
ADA ID: CEA5DA6CABB6	Curb Cut Type: MedianRefuge2	Initial Pass/Fail: Fail	Overall Compliance: No
Codes/Mitigation Info/Possible Solution		Field Measurements/Component Compliance	
Severity Score: 8.75

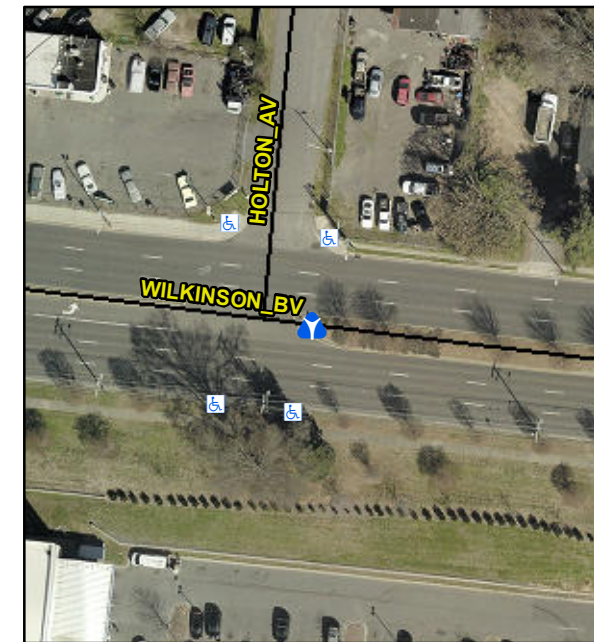
Compliance	Description	Data	Compliance	Description	Data
No	Refuge 1 Length (In)	35.0	N/A	Gutter 1 Ponding?	N/A
No	Refuge 1 Width (In)	56.0	N/A	Gutter 1 Lip Ht (In)	N/A
Yes	Refuge 1 Slope (%)	0.8	N/A	Gutter 1 Slope (%)	N/A
Yes	Refuge 1 X Slope (%)	2.6	N/A	Gutter 1 X Slope (%)	N/A
N/A	Painted X Walk1?	No	N/A	DWS 1 Provided?	N/A
N/A	X Walk 1 Direction	To N	N/A	DWS 1 Contrast?	N/A
N/A	X Walk 1 Width (In)	N/A	N/A	DWS 1 Length (In)	N/A
N/A	Road 1 Slope (%)	2.2	N/A	DWS 1 Full Width?	N/A
N/A	Road 1 X Slope (%)	2.7	N/A	DWS 1 Offset (In)	N/A
No	Refuge 2 Length (In)	35.0	N/A	Gutter 2 Ponding?	N/A
No	Refuge 2 Width (In)	56.0	N/A	Gutter 2 Lip Ht (In)	N/A
Yes	Refuge 2 Slope (%)	0.2	N/A	Gutter 2 Slope (%)	N/A
Yes	Refuge 2 X Slope (%)	1.9	N/A	Gutter 2 X Slope (%)	N/A
N/A	Painted X Walk2?	No	N/A	DWS 2 Provided?	N/A
N/A	X Walk 2 Direction	To S	N/A	DWS 2 Contrast?	N/A
N/A	X Walk 2 Width (In)	N/A	N/A	DWS 2 Length (In)	N/A
N/A	Road 2 Slope (%)	3.0	N/A	DWS 2 Full Width?	N/A

N/A	Road 2 X Slope (%)	3.6	N/A	DWS 2 Offset (In)	N/A
N/A	Refuge 3 Length (in)	N/A	N/A	Gutter 3 Ponding?	N/A
N/A	Refuge 3 Width (in)	N/A	N/A	Gutter 3 Lip Ht (in)	N/A
N/A	Refuge 3 Slope (%)	N/A	N/A	Gutter 3 Slope (%)	N/A
N/A	Refuge 3 XSlope (%)	N/A	N/A	Gutter 3 XSlope (%)	N/A
N/A	Painted X Walk3?	N/A	N/A	DWS 3 Provided?	N/A
N/A	X Walk 3 Direction	N/A	N/A	DWS 3 Contrast?	N/A
N/A	X Walk 3 Width (in)	N/A	N/A	DWS 3 Length (in)	N/A
N/A	Road 3 Slope (%)	N/A	N/A	DWS 3 Full Width?	N/A
N/A	Road 3 XSlope (%)	N/A	N/A	DWS 3 Offset (in)	N/A
Yes	Any Obstructions?	N/A	N/A	Storm Grate/Utility Hazard?	N/A
N/A	Obstruction Type		N/A	Storm Grate/Utility Type	
		N/A			N/A
N/A	Surface Condition	Good

Possible Solutions:

Remove & Replace Entire Refuge.
