# Access Compliance Report

## Public Rights-of-Way

### (Island Curb Cuts)

Intersection ID: 5600	Main Street: N_TRYON_ST	Cross Street: J_M_KEYNES_DR	Location: SW
ADA ID: CF35D4401F52	Curb Cut Type: MedianRefuge2	Initial Pass/Fail: Fail	Overall Compliance: No
Severity Score: 0			
Codes/Mitigation Info/Possible Solution		Field Measurements/Component Compliance

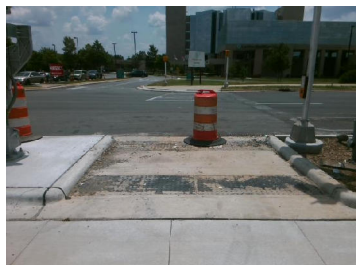
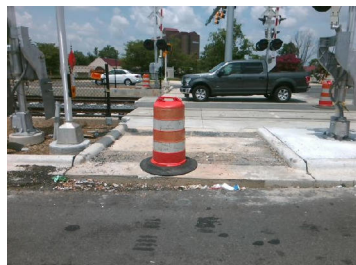
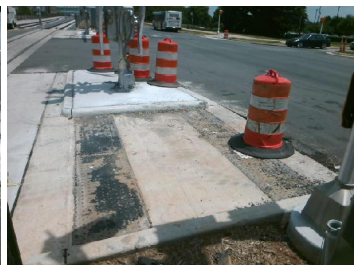
Compliance	Description	Data	Compliance	Description	Data
Yes	Refuge 1 Length (In)	47.0	N/A	Gutter 1 Ponding?	N/A
Yes	Refuge 1 Width (In)	120.0	N/A	Gutter 1 Lip Ht (In)	N/A
Yes	Refuge 1 Slope (%)	0.4	N/A	Gutter 1 Slope (%)	N/A
Yes	Refuge 1 X Slope (%)	1.0	N/A	Gutter 1 X Slope (%)	N/A
N/A	Painted X Walk1?	No	N/A	DWS 1 Provided?	N/A
N/A	X Walk 1 Direction	To NW	N/A	DWS 1 Contrast?	N/A
N/A	X Walk 1 Width (In)	N/A	N/A	DWS 1 Length (In)	N/A
N/A	Road 1 Slope (%)	0.0	N/A	DWS 1 Full Width?	N/A
N/A	Road 1 X Slope (%)	0.5	N/A	DWS 1 Offset (In)	N/A
Yes	Refuge 2 Length (In)	47.0	N/A	Gutter 2 Ponding?	N/A
Yes	Refuge 2 Width (In)	120.0	N/A	Gutter 2 Lip Ht (In)	N/A
Yes	Refuge 2 Slope (%)	1.7	N/A	Gutter 2 Slope (%)	N/A
Yes	Refuge 2 X Slope (%)	0.2	N/A	Gutter 2 X Slope (%)	N/A
N/A	Painted X Walk2?	No	N/A	DWS 2 Provided?	N/A
N/A	X Walk 2 Direction	To SE	N/A	DWS 2 Contrast?	N/A
N/A	X Walk 2 Width (In)	N/A	N/A	DWS 2 Length (In)	N/A

N/A	Road 2 Slope (%)	0.6	N/A	DWS 2 Full Width?	N/A
N/A	Road 2 X Slope (%)	0.3	N/A	DWS 2 Offset (In)	N/A
N/A	Refuge 3 Length (in)	N/A	N/A	Gutter 3 Ponding?	N/A
N/A	Refuge 3 Width (in)	N/A	N/A	Gutter 3 Lip Ht (in)	N/A
N/A	Refuge 3 Slope (%)	N/A	N/A	Gutter 3 Slope (%)	N/A
N/A	Refuge 3 XSlope (%)	N/A	N/A	Gutter 3 XSlope (%)	N/A
N/A	Painted X Walk3?	No	N/A	DWS 3 Provided?	N/A
N/A	X Walk 3 Direction	N/A	N/A	DWS 3 Contrast?	N/A
N/A	X Walk 3 Width (in)	N/A	N/A	DWS 3 Length (in)	N/A
N/A	Road 3 Slope (%)	N/A	N/A	DWS 3 Full Width?	N/A
N/A	Road 3 XSlope (%)	N/A	N/A	DWS 3 Offset (in)	N/A
Yes	Any Obstructions?	N/A	N/A	Storm Grate/Utility Hazard?	N/A
N/A	Obstruction Type		N/A	Storm Grate/Utility Type	
		N/A			N/A
N/A	Surface Condition	Good

**Remove & Replace Entire Refuge.**
