Access Compliance Report

Public Rights-of-Way

(Island Curb Cuts)

Intersection ID: 17739	Main Street: E_WOODLAWN_RD	Cross Street: SOUTH_BV	Location: E
ADA ID: CF6A5C3A32F0	Curb Cut Type: MedianRefuge2	Initial Pass/Fail: Fail	Overall Compliance: No
Codes/Mitigation Info/Possible Solution		Field Measurements/Component Compliance	
Severity Score: 0

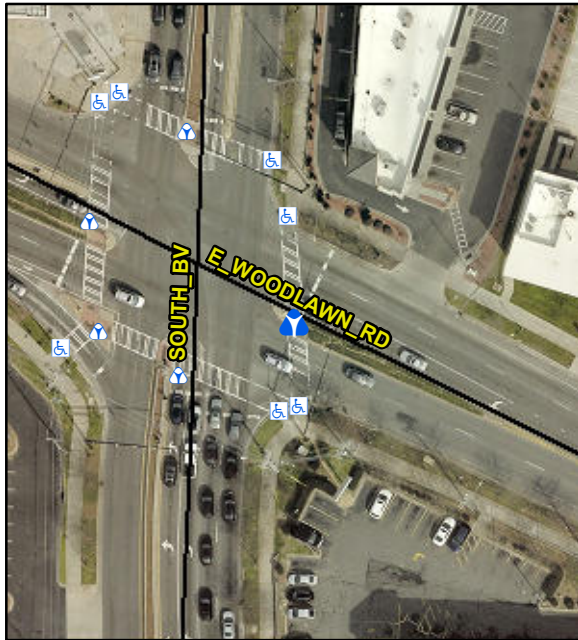
Compliance	Description	Data	Compliance	Description	Data
Yes	Refuge 1 Length (In)	56.0	N/A	Gutter 1 Ponding?	N/A
Yes	Refuge 1 Width (In)	114.0	N/A	Gutter 1 Lip Ht (In)	N/A
Yes	Refuge 1 Slope (%)	1.9	N/A	Gutter 1 Slope (%)	N/A
Yes	Refuge 1 X Slope (%)	3.4	N/A	Gutter 1 X Slope (%)	N/A
N/A	Painted X Walk1?	Yes	N/A	DWS 1 Provided?	N/A
N/A	X Walk 1 Direction	To S	N/A	DWS 1 Contrast?	N/A
N/A	X Walk 1 Width (In)	120.0	N/A	DWS 1 Length (In)	N/A
N/A	Road 1 Slope (%)	4.6	N/A	DWS 1 Full Width?	N/A
N/A	Road 1 X Slope (%)	3.1	N/A	DWS 1 Offset (In)	N/A
Yes	Refuge 2 Length (In)	56.0	N/A	Gutter 2 Ponding?	N/A
Yes	Refuge 2 Width (In)	114.0	N/A	Gutter 2 Lip Ht (In)	N/A
Yes	Refuge 2 Slope (%)	0.4	N/A	Gutter 2 Slope (%)	N/A
Yes	Refuge 2 X Slope (%)	2.8	N/A	Gutter 2 X Slope (%)	N/A
N/A	Painted X Walk2?	Yes	N/A	DWS 2 Provided?	N/A
N/A	X Walk 2 Direction	To N	N/A	DWS 2 Contrast?	N/A
N/A	X Walk 2 Width (In)	116.0	N/A	DWS 2 Length (In)	N/A

N/A	Road 2 Slope (%)	3.9	N/A	DWS 2 Full Width?	N/A
N/A	Road 2 X Slope (%)	1.9	N/A	DWS 2 Offset (In)	N/A
N/A	Refuge 3 Length (in)	N/A	N/A	Gutter 3 Ponding?	N/A
N/A	Refuge 3 Width (in)	N/A	N/A	Gutter 3 Lip Ht (in)	N/A
N/A	Refuge 3 Slope (%)	N/A	N/A	Gutter 3 Slope (%)	N/A
N/A	Refuge 3 XSlope (%)	N/A	N/A	Gutter 3 XSlope (%)	N/A
N/A	Painted X Walk3?	N/A	N/A	DWS 3 Provided?	N/A
N/A	X Walk 3 Direction	N/A	N/A	DWS 3 Contrast?	N/A
N/A	X Walk 3 Width (in)	N/A	N/A	DWS 3 Length (in)	N/A
N/A	Road 3 Slope (%)	N/A	N/A	DWS 3 Full Width?	N/A
N/A	Road 3 XSlope (%)	N/A	N/A	DWS 3 Offset (in)	N/A
Yes	Any Obstructions?	N/A	N/A	Storm Grate/Utility Hazard?	N/A
N/A	Obstruction Type		N/A	Storm Grate/Utility Type	
		N/A			N/A
N/A	Surface Condition	Good

Remove & Replace Entire Refuge.

Total Cost: \$ 3000.00
