Access Compliance Report

Public Rights-of-Way

(Island Curb Cuts)

Intersection ID: 44555	Main Street: UNIVERSITY_CITY_BV	Cross Street: N_TRYON_ST	Location: N
ADA ID: CF9D4E0AD543	Curb Cut Type: MedianRefuge2	Initial Pass/Fail: Fail	Overall Compliance: No
Codes/Mitigation Info/Possible Solution		Field Measurements/Component Compliance

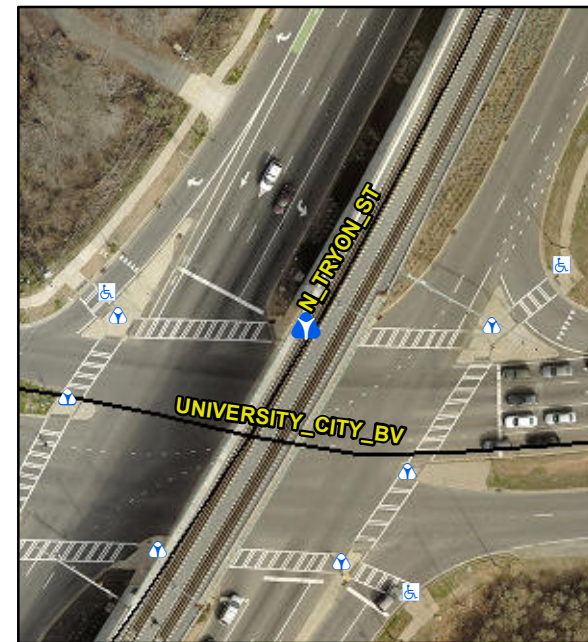
Compliance	Description	Data	Compliance	Description	Data
Yes	Refuge 1 Length (In)	234.5	N/A	Gutter 1 Ponding?	N/A
Yes	Refuge 1 Width (In)	95.0	N/A	Gutter 1 Lip Ht (In)	N/A
Yes	Refuge 1 Slope (%)	0.6	N/A	Gutter 1 Slope (%)	N/A
Yes	Refuge 1 X Slope (%)	3.0	N/A	Gutter 1 X Slope (%)	N/A
N/A	Painted X Walk1?	Yes	N/A	DWS 1 Provided?	N/A
N/A	X Walk 1 Direction	To E	N/A	DWS 1 Contrast?	N/A
N/A	X Walk 1 Width (In)	119.0	N/A	DWS 1 Length (In)	N/A
N/A	Road 1 Slope (%)	2.7	N/A	DWS 1 Full Width?	N/A
N/A	Road 1 X Slope (%)	0.6	N/A	DWS 1 Offset (In)	N/A
Yes	Refuge 2 Length (In)	234.5	N/A	Gutter 2 Ponding?	N/A
Yes	Refuge 2 Width (In)	94.5	N/A	Gutter 2 Lip Ht (In)	N/A
Yes	Refuge 2 Slope (%)	0.2	N/A	Gutter 2 Slope (%)	N/A
Yes	Refuge 2 X Slope (%)	2.2	N/A	Gutter 2 X Slope (%)	N/A
N/A	Painted X Walk2?	Yes	N/A	DWS 2 Provided?	N/A
N/A	X Walk 2 Direction	To W	N/A	DWS 2 Contrast?	N/A
N/A	X Walk 2 Width (In)	109.0	N/A	DWS 2 Length (In)	N/A

N/A	Road 2 Slope (%)	1.8	N/A	DWS 2 Full Width?	N/A
N/A	Road 2 X Slope (%)	0.9	N/A	DWS 2 Offset (In)	N/A
N/A	Refuge 3 Length (in)	N/A	N/A	Gutter 3 Ponding?	N/A
N/A	Refuge 3 Width (in)	N/A	N/A	Gutter 3 Lip Ht (in)	N/A
N/A	Refuge 3 Slope (%)	N/A	N/A	Gutter 3 Slope (%)	N/A
N/A	Refuge 3 XSlope (%)	N/A	N/A	Gutter 3 XSlope (%)	N/A
N/A	Painted X Walk3?	No	N/A	DWS 3 Provided?	N/A
N/A	X Walk 3 Direction	N/A	N/A	DWS 3 Contrast?	N/A
N/A	X Walk 3 Width (in)	N/A	N/A	DWS 3 Length (in)	N/A
N/A	Road 3 Slope (%)	N/A	N/A	DWS 3 Full Width?	N/A
N/A	Road 3 XSlope (%)	N/A	N/A	DWS 3 Offset (in)	N/A
Yes	Any Obstructions?	N/A	N/A	Storm Grate/Utility Hazard?	N/A
N/A	Obstruction Type		N/A	Storm Grate/Utility Type	
		N/A			N/A
N/A	Surface Condition	Good

Possible Solutions:

Remove & Replace Entire Refuge.

Total Cost: \$ 3000.00
