Access Compliance Report

Public Rights-of-Way

(Island Curb Cuts)

| Intersection ID: 7091 | Main Street: BROOKSHIRE_BV | Cross Street: HOVIS_RD | Location: E |

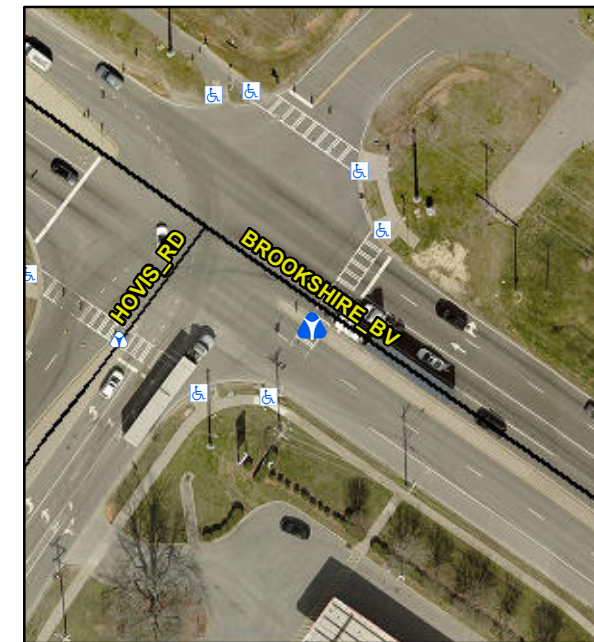
| ADA ID: CFC77514BE89 | Curb Cut Type: MedianRefuge2 | Initial Pass/Fail: Fail | Overall Compliance: No |

| Compliance | Description | Data | Compliance | Description | Data |
|---|---|---|---|---|---|
| No | Refuge 1 Length (In) | 34.0 | N/A | Gutter 1 Ponding? | N/A |
| No | Refuge 2 Length (In) | 34.0 | N/A | Gutter 2 Ponding? | N/A |

Remove & Replace Entire Refuge.

Total Cost: \$ 3000.00
