Access Compliance Report

Public Rights-of-Way

(Island Curb Cuts)

Intersection ID: 12625	Main Street: E_10TH_ST	Cross Street: E_12TH_ST	Location: NE
ADA ID: D17888EA4A9C	Curb Cut Type: MedianRefuge2	Initial Pass/Fail: Fail	Overall Compliance: No
Codes/Mitigation Info/Possible Solution		Field Measurements/Component Compliance	
Severity Score: 1.25

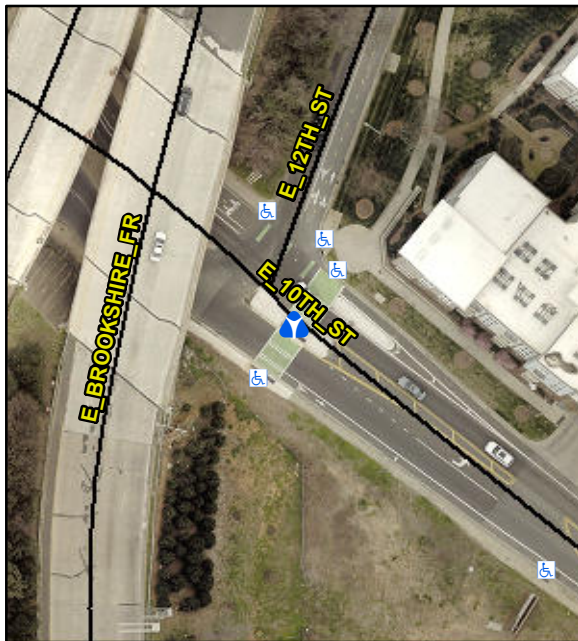
Compliance	Description	Data	Compliance	Description	Data
Yes	Refuge 1 Length (In)	131.0	N/A	Gutter 1 Ponding?	N/A
Yes	Refuge 1 Width (In)	89.0	N/A	Gutter 1 Lip Ht (In)	N/A
Yes	Refuge 1 Slope (%)	2.7	N/A	Gutter 1 Slope (%)	N/A
Yes	Refuge 1 X Slope (%)	4.0	N/A	Gutter 1 X Slope (%)	N/A
N/A	Painted X Walk1?	No	N/A	DWS 1 Provided?	N/A
N/A	X Walk 1 Direction	To NE	N/A	DWS 1 Contrast?	N/A
N/A	X Walk 1 Width (In)	N/A	N/A	DWS 1 Length (In)	N/A
N/A	Road 1 Slope (%)	2.5	N/A	DWS 1 Full Width?	N/A
N/A	Road 1 X Slope (%)	2.7	N/A	DWS 1 Offset (In)	N/A
Yes	Refuge 2 Length (In)	131.0	N/A	Gutter 2 Ponding?	N/A
Yes	Refuge 2 Width (In)	89.0	N/A	Gutter 2 Lip Ht (In)	N/A
Yes	Refuge 2 Slope (%)	2.5	N/A	Gutter 2 Slope (%)	N/A
Yes	Refuge 2 X Slope (%)	3.1	N/A	Gutter 2 X Slope (%)	N/A
N/A	Painted X Walk2?	No	N/A	DWS 2 Provided?	N/A
N/A	X Walk 2 Direction	To SW	N/A	DWS 2 Contrast?	N/A
N/A	X Walk 2 Width (In)	N/A	N/A	DWS 2 Length (In)	N/A

N/A	Road 2 Slope (%)	2.9	N/A	DWS 2 Full Width?	N/A
N/A	Road 2 X Slope (%)	2.0	N/A	DWS 2 Offset (In)	N/A
N/A	Refuge 3 Length (in)	N/A	N/A	Gutter 3 Ponding?	N/A
N/A	Refuge 3 Width (in)	N/A	N/A	Gutter 3 Lip Ht (in)	N/A
N/A	Refuge 3 Slope (%)	N/A	N/A	Gutter 3 Slope (%)	N/A
N/A	Refuge 3 XSlope (%)	N/A	N/A	Gutter 3 XSlope (%)	N/A
N/A	Painted X Walk3?	N/A	N/A	DWS 3 Provided?	N/A
N/A	X Walk 3 Direction	N/A	N/A	DWS 3 Contrast?	N/A
N/A	X Walk 3 Width (in)	N/A	N/A	DWS 3 Length (in)	N/A
N/A	Road 3 Slope (%)	N/A	N/A	DWS 3 Full Width?	N/A
N/A	Road 3 XSlope (%)	N/A	N/A	DWS 3 Offset (in)	N/A
Yes	Any Obstructions?	N/A	N/A	Storm Grate/Utility Hazard?	N/A
N/A	Obstruction Type		N/A	Storm Grate/Utility Type	
		N/A			N/A
N/A	Surface Condition	Good

Remove & Replace Entire Refuge.
