Access Compliance Report

Public Rights-of-Way

(Island Curb Cuts)

Intersection ID: 7770	Main Street: E_ARROWHEAD_DR	Cross Street: N_TRYON_ST	Location:	N
ADA ID: D357A8A74646	Curb Cut Type: MedianRefuge2	Initial Pass/Fail: Pass	Overall Compliance: No	Severity Score: 15
Codes/Mitigation Info/Possible Solution		Field Measurements/Component Compliance

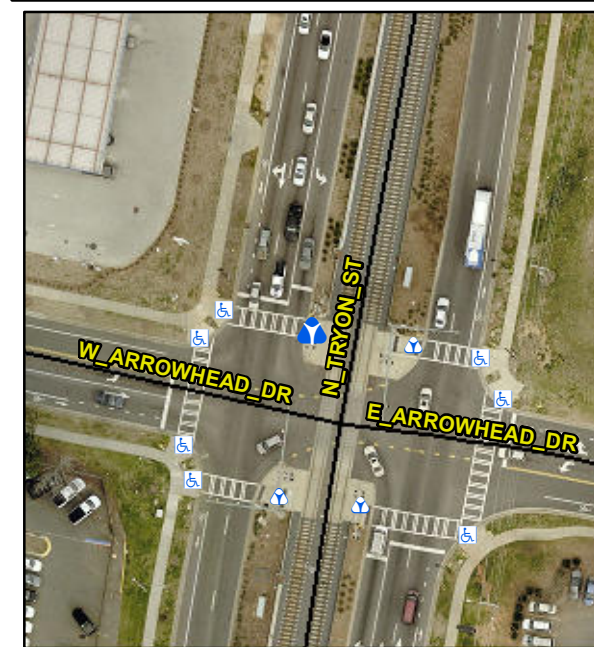
Compliance	Description	Data	Compliance	Description	Data
Yes	Refuge 1 Length (In)	48.0	Yes	Gutter 1 Ponding?	No
Yes	Refuge 1 Width (In)	121.0	No	Gutter 1 Lip Ht (In)	1.0
Yes	Refuge 1 Slope (%)	0.1	Yes	Gutter 1 Slope (%)	1.9
Yes	Refuge 1 X Slope (%)	0.9	Yes	Gutter 1 X Slope (%)	0.1
N/A	Painted X Walk1?	Yes	Yes	DWS 1 Provided?	Yes
N/A	X Walk 1 Direction	To W	Yes	DWS 1 Contrast?	Yes
N/A	X Walk 1 Width (In)	120.0	Yes	DWS 1 Length (In)	24.0
N/A	Road 1 Slope (%)	0.3	Yes	DWS 1 Full Width?	Yes
N/A	Road 1 X Slope (%)	2.4	Yes	DWS 1 Offset (In)	2.0
Yes	Refuge 2 Length (In)	48.0	Yes	Gutter 2 Ponding?	No
Yes	Refuge 2 Width (In)	121.0	Yes	Gutter 2 Lip Ht (In)	0.0
Yes	Refuge 2 Slope (%)	0.7	Yes	Gutter 2 Slope (%)	2.3
Yes	Refuge 2 X Slope (%)	0.0	Yes	Gutter 2 X Slope (%)	0.4
N/A	Painted X Walk2?	No	Yes	DWS 2 Provided?	Yes
N/A	X Walk 2 Direction	To E	Yes	DWS 2 Contrast?	Yes
N/A	X Walk 2 Width (In)	N/A	Yes	DWS 2 Length (In)	24.0

Grind Gutter Lip.

Total Cost: \$ 200.00
