Access Compliance Report

Public Rights-of-Way

(Island Curb Cuts)

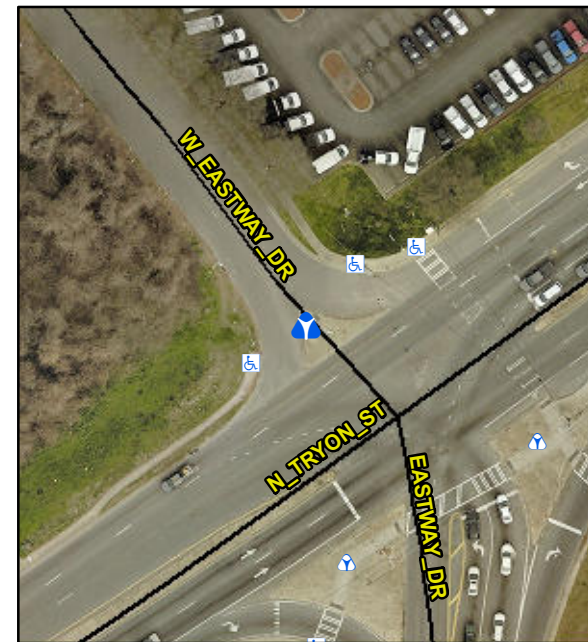
Intersection ID: 8739	Main Street: N_TRYON_ST	Cross Street: W_EASTWAY_DR	Location: NW
ADA ID: D54EDB09A9E3	Curb Cut Type: MedianRefuge2	Initial Pass/Fail: Fail	Overall Compliance: No
Codes/Mitigation Info/Possible Solution		Field Measurements/Component Compliance

Remove & Replace Entire Refuge.
