# Access Compliance Report

## Public Rights-of-Way

### (Island Curb Cuts)

Intersection ID: 17435	Main Street: E_INDEPENDENCE_BV	Cross Street: BUICK_DR	Location: NE
ADA ID: D5934071081A	Curb Cut Type: MedianRefuge2	Initial Pass/Fail: Fail	Overall Compliance: No
Severity Score: 1.25			
Codes/Mitigation Info/Possible Solution		Field Measurements/Component Compliance

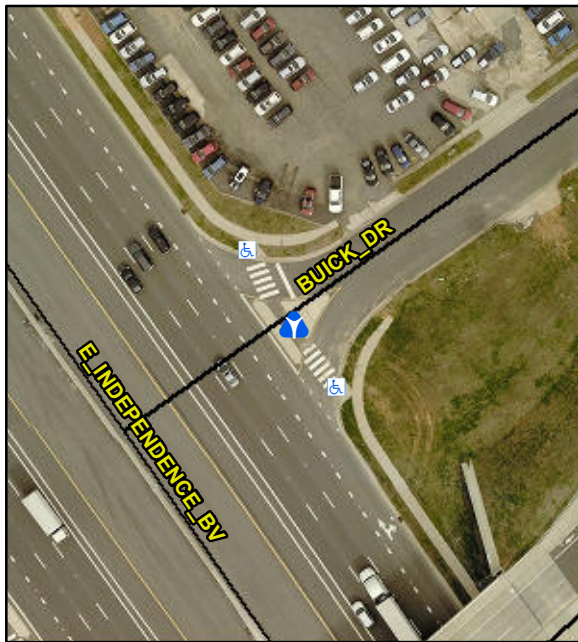
Compliance	Description	Data	Compliance	Description	Data
Yes	Refuge 1 Length (In)	148.0	N/A	Gutter 1 Ponding?	N/A
Yes	Refuge 1 Width (In)	74.0	N/A	Gutter 1 Lip Ht (In)	N/A
Yes	Refuge 1 Slope (%)	2.3	N/A	Gutter 1 Slope (%)	N/A
Yes	Refuge 1 X Slope (%)	4.5	N/A	Gutter 1 X Slope (%)	N/A
N/A	Painted X Walk1?	Yes	N/A	DWS 1 Provided?	N/A
N/A	X Walk 1 Direction	To NW	N/A	DWS 1 Contrast?	N/A
N/A	X Walk 1 Width (In)	123.0	N/A	DWS 1 Length (In)	N/A
N/A	Road 1 Slope (%)	4.3	N/A	DWS 1 Full Width?	N/A
N/A	Road 1 X Slope (%)	0.5	N/A	DWS 1 Offset (In)	N/A
Yes	Refuge 2 Length (In)	148.0	N/A	Gutter 2 Ponding?	N/A
Yes	Refuge 2 Width (In)	74.0	N/A	Gutter 2 Lip Ht (In)	N/A
Yes	Refuge 2 Slope (%)	2.9	N/A	Gutter 2 Slope (%)	N/A
Yes	Refuge 2 X Slope (%)	0.0	N/A	Gutter 2 X Slope (%)	N/A
N/A	Painted X Walk2?	Yes	N/A	DWS 2 Provided?	N/A
N/A	X Walk 2 Direction	To SE	N/A	DWS 2 Contrast?	N/A
N/A	X Walk 2 Width (In)	118.0	N/A	DWS 2 Length (In)	N/A

N/A	Road 2 Slope (%)	2.2	N/A	DWS 2 Full Width?	N/A
N/A	Road 2 X Slope (%)	0.1	N/A	DWS 2 Offset (In)	N/A
N/A	Refuge 3 Length (in)	N/A	N/A	Gutter 3 Ponding?	N/A
N/A	Refuge 3 Width (in)	N/A	N/A	Gutter 3 Lip Ht (in)	N/A
N/A	Refuge 3 Slope (%)	N/A	N/A	Gutter 3 Slope (%)	N/A
N/A	Refuge 3 XSlope (%)	N/A	N/A	Gutter 3 XSlope (%)	N/A
N/A	Painted X Walk3?	N/A	N/A	DWS 3 Provided?	N/A
N/A	X Walk 3 Direction	N/A	N/A	DWS 3 Contrast?	N/A
N/A	X Walk 3 Width (in)	N/A	N/A	DWS 3 Length (in)	N/A
N/A	Road 3 Slope (%)	N/A	N/A	DWS 3 Full Width?	N/A
N/A	Road 3 XSlope (%)	N/A	N/A	DWS 3 Offset (in)	N/A
Yes	Any Obstructions?	N/A	N/A	Storm Grate/Utility Hazard?	N/A
N/A	Obstruction Type		N/A	Storm Grate/Utility Type	
		N/A			N/A
N/A	Surface Condition	Good

**Remove & Replace Entire Refuge.**
