Access Compliance Report

Public Rights-of-Way

(Island Curb Cuts)

| Intersection ID: 48600 | Main Street: GRANDIFLORA_DR | Cross Street: LITTLE_GEM_LN | Location: | N |

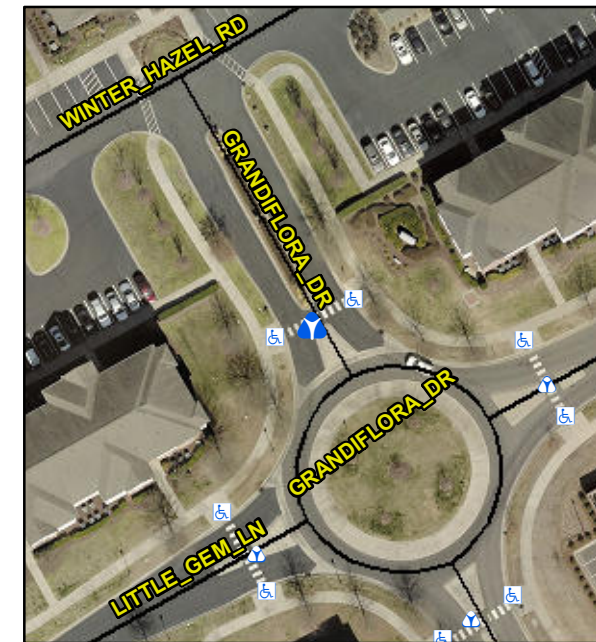
| ADA ID: D682AC35AFDE | Curb Cut Type: MedianRefuge2 | Initial Pass/Fail: Fail | Overall Compliance: No | Severity Score: 0 |

| Compliance | Description | Data | Compliance | Description | Data |
|---|---|---|---|---|---|
| No | Refuge 1 Length (In) | 32.0 | N/A | Gutter 1 Ponding? | N/A |
| No | Refuge 2 Length (In) | 32.0 | N/A | Gutter 2 Ponding? | N/A |

Remove & Replace Entire Refuge.

Total Cost: \$ 3000.00
