# Access Compliance Report

## Public Rights-of-Way

### (Island Curb Cuts)

| Intersection ID: 12779 | Main Street: E_TRADE_ST | Cross Street: S_DAVIDSON_ST | Location: E |

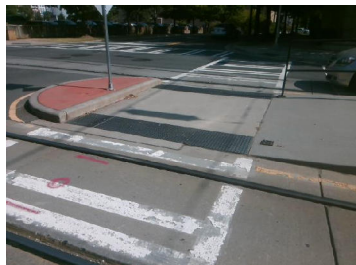
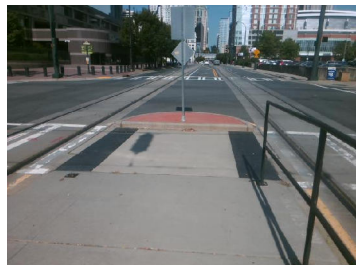
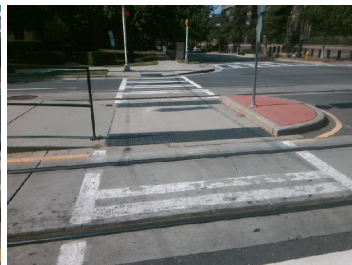
| Compliance | Description | Data | Compliance | Description | Data |
|---|---|---|---|---|---|
| Yes | Refuge 1 Width (In) | 119.0 | No | Gutter 1 Lip Ht (In) | 0.25 |
| Yes | Refuge 2 Width (In) | 119.0 | No | Gutter 2 Lip Ht (In) | 0.25 |

**Grind Gutter Lip.**
