Access Compliance Report

Public Rights-of-Way

(Island Curb Cuts)

| Intersection ID: 4279 | Main Street: LAKEVIEW_RD | Cross Street: REAMES_RD | Location: NE |

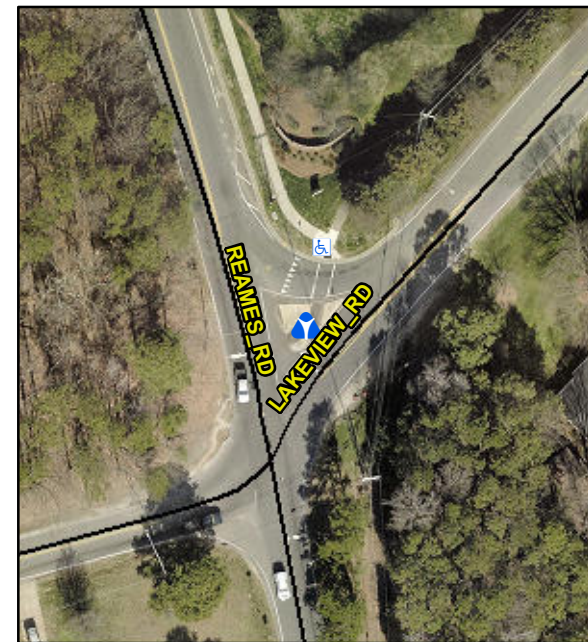
| ADA ID: D793B0939CF1 | Curb Cut Type: IslandRefuge3 | Initial Pass/Fail: Pass | Overall Compliance: No |
| Severity Score: 20.25 | | | |

| Compliance | Description | Data | Compliance | Description | Data |
|---|---|---|---|---|---|
| Yes | Refuge 1 Length (In) | 96.0 | No | Gutter 1 Ponding? | Yes |
| N/A | Painted X Walk1? | Yes | No | DWS 1 Provided? | No |
| Yes | Refuge 2 Length (In) | 120.0 | No | Gutter 2 Ponding? | Yes |
| N/A | Painted X Walk2? | No | No | DWS 2 Provided? | No |
| Yes | Refuge 3 Length (in) | 105.0 | No | Gutter 3 Ponding? | Yes |
| Yes | Refuge 3 XSlope (%) | 1.9 | No | Gutter 3 XSlope (%) | 2.1 |
| N/A | Painted X Walk3? | No | No | DWS 3 Provided? | No |

**Install Detectable Warning System.
Fix Gutter Ponding. Remove &
Replace Gutter.**

Total Cost: \$ 2455.00
